Case Study

B-Moldova

National Road M3 - Congaz

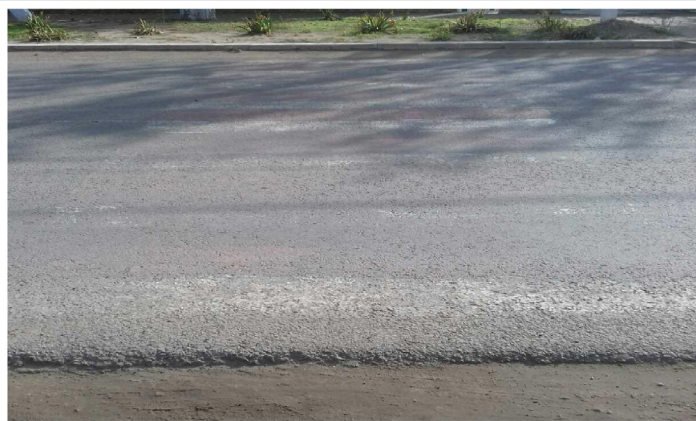
- Low quality pedestrian crossing facility (badly worn road markings making it almost invisible (Picture 2) and a lack of supporting information to drivers)
- Vehicles parking close to the pedestrian crossing
- Inadequate sight distances
- Pedestrian sidewalk not connected to the pedestrian crossing
- Lack of the marking of the crossings, or very poor condition of the marking
- Absence of signs “Attention school zone”
- Vehicles speeding and not giving way to pedestrians
- Absence of a low-speed zone in the proximity of the school crossings
- Lack of speed calming measures, such as speed bumps.

Picture 2. Pedestrian crossing at Congaz (before upgrade)

In order to provide at least some risk reduction immediately, a preliminary set of low-cost recommendations were made, accepted and implemented (see Figure 3):

- re-painting of the markings
- road marking “School”
- installation of warning signs “school zone”
- crossing supervisor presence during the rush hours.

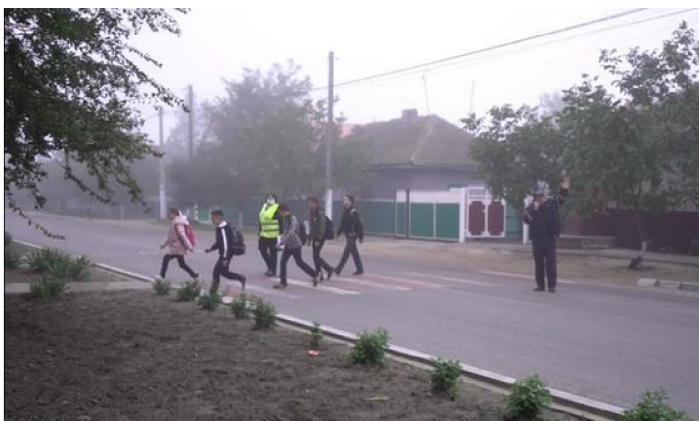
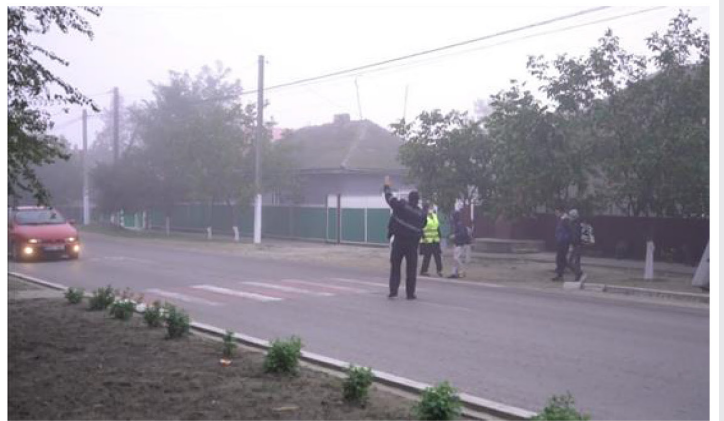
Picture 3. Crossing supervisor on action (Stage 1 countermeasures applied)

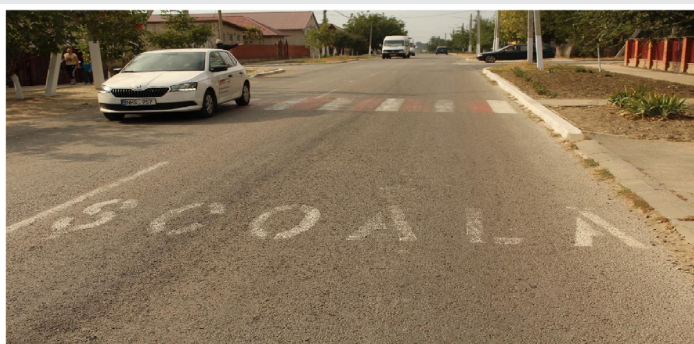
Picture 4. Road markings (Stage 1 countermeasures applied)

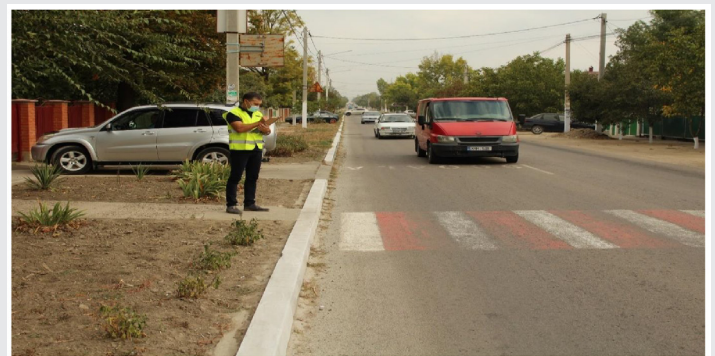
The Stage 1 low-cost measures involved repainting the crossing, installing warning signs 'School zone' and 'Beware kids' and providing a school crossing supervisor at the start and end of the school day. The location achieved a 3-star rating (Figure 2) although it can be seen that the road markings are of low quality and wore away quickly and that much would depend upon the role of the school crossing supervisor in reducing risk. Very little has been done to reduce the risk built-in to the road environment or to influence the behaviour of drivers or indeed of pedestrians. At most times of the day it would not be unreasonable to expect that the risk at this location would be little-changed.

Picture 5. Assessing the infrastructure with SR4S app (Stage 1 countermeasures applied)
