STAR RATING
FOR SCHOOLS

Safe crossings - safe journeys project

**School zone assessment in 3 localities:
Balti, Singerei and Ungheni municipalities**

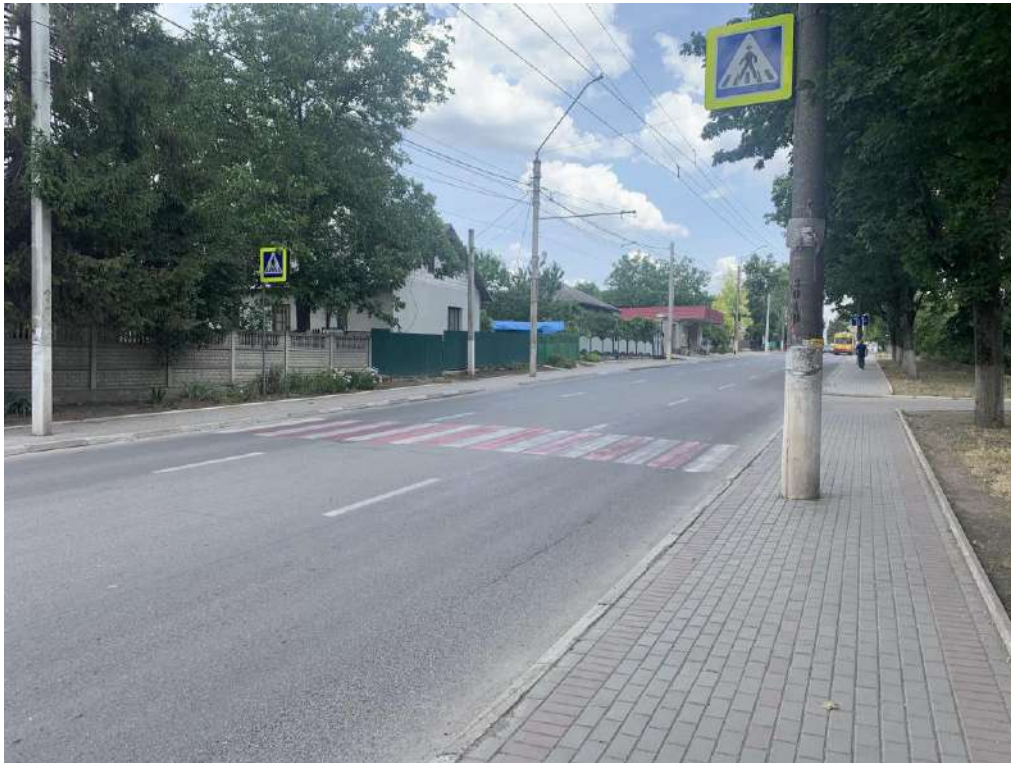
The assessment established that Calea Iesilor street is a street with three lanes of traffic in both directions, the middle lane being an overtaking lane in both directions. Each lane is 3 metres wide, forming a carriageway almost 10 metres wide.

Figure 4: Balti, Calea Iesilor street, area of "Stefan cel Mare" and "B.P.Hasdeu" Lyceums

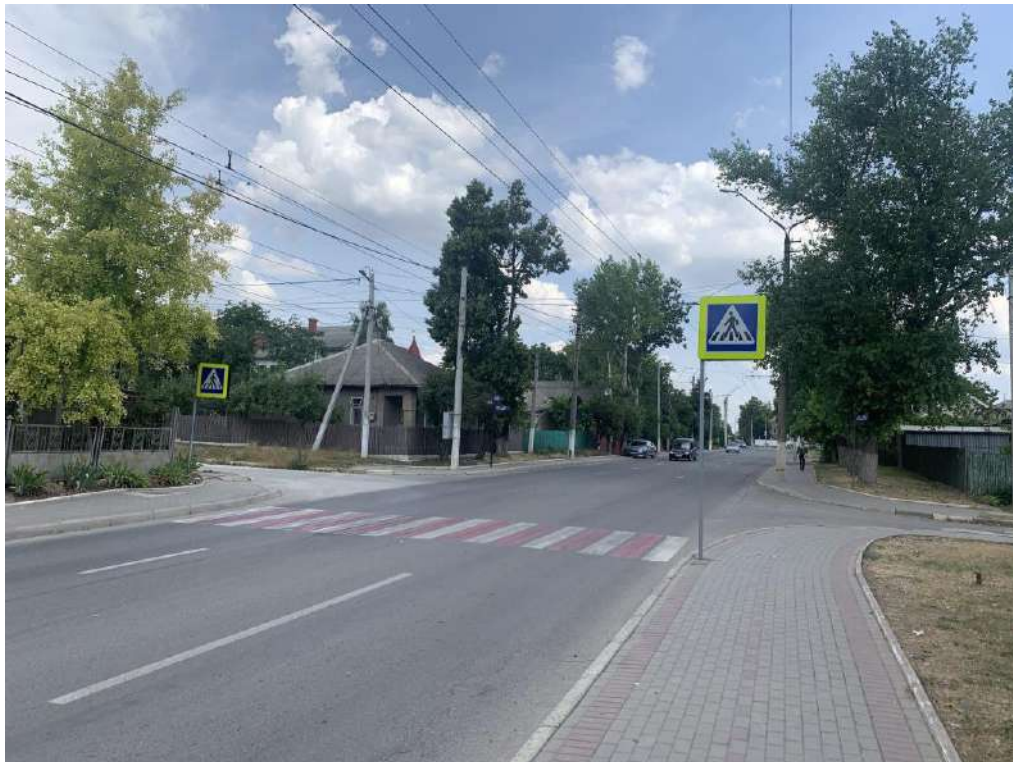
Throughout the evaluated length, intersections and pedestrian crossings are not signaled and the street has priority in relation to the intersected ones.

All these characteristics favour the high-speed circulation of cars, especially in the situation of overtaking public transport. Along the entire length of the street, cars travel at speeds that considerably exceed 50 km/h.

Figure 5: Balti, Calea Iesilor street, area of "Stefan cel Mare" and "B. P. Hasdeu" Lyceums

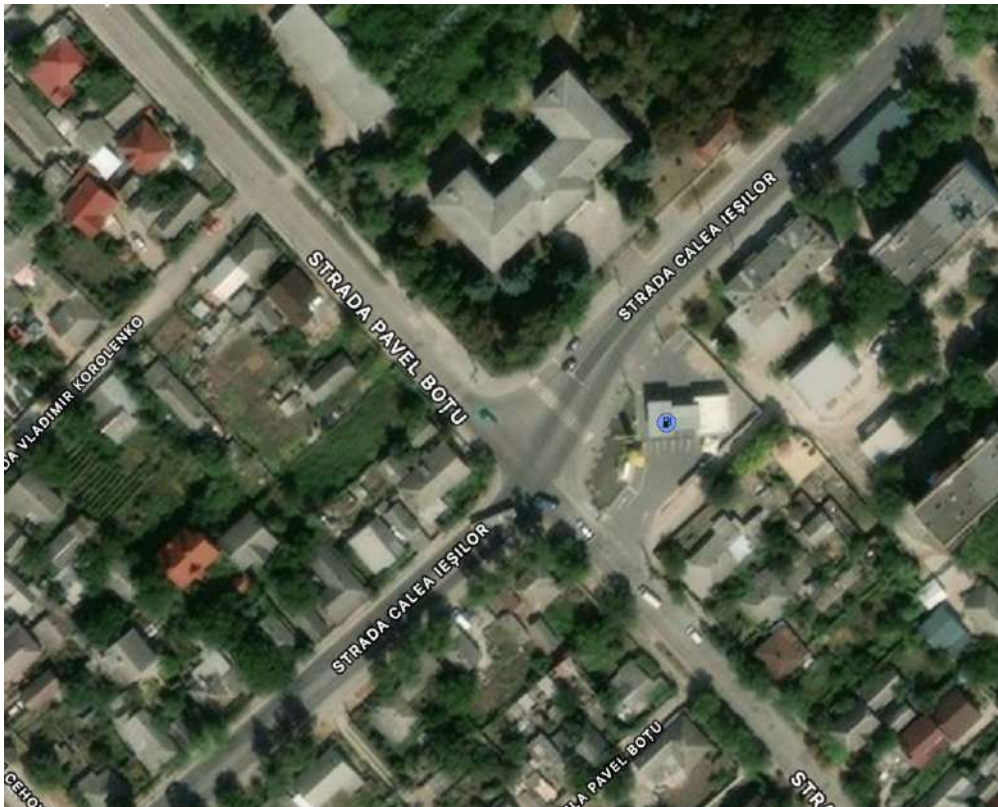
At the intersection of Calea Iesilor street with Pavel Botu street, the axis of the street is shifted and the radius of the curves allow turning at speed, which causes the widening of the carriageway. In this intersection, the pedestrian crossing is more than 15 metres wide, which increases the risk of pedestrian injuries.

Along the entire length of the analysed segment, pedestrian crossings are marked and signposted, but there are no signs that would prevent drivers from approaching the school area. Also, pedestrian crossings are marked only on one side of the analysed intersections.

Figure 6: Balti, Calea Iesilor street, area of "Stefan cel Mare" and "B.P.Hasdeu" Lyceums

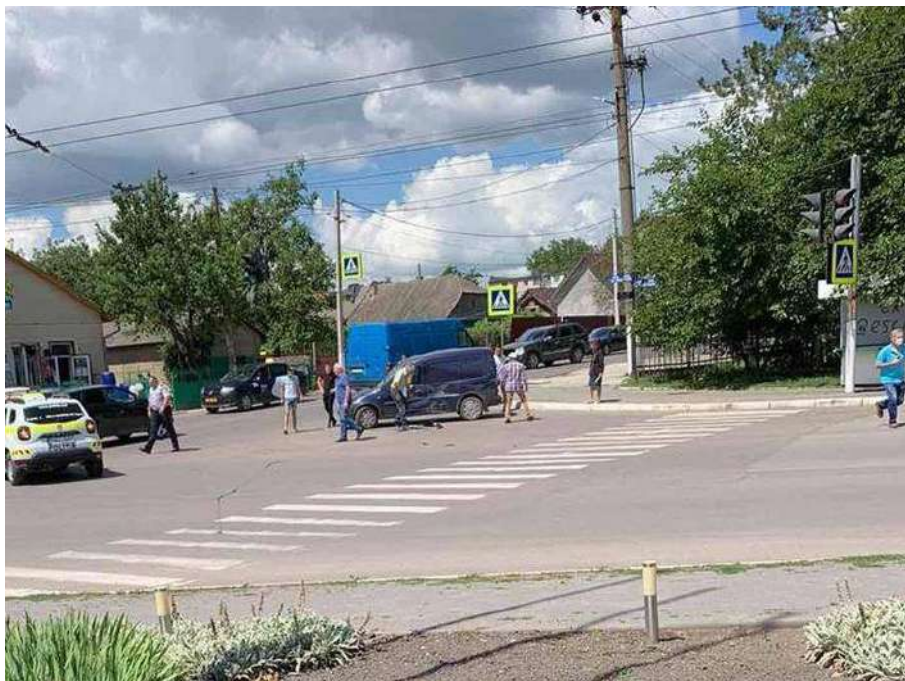
Figure 7: Car crash on Calea Iesilor str. on 13.07.2020. Source: <https://protv.md/actualitate/grav-accident-la-balti-cu-implicarea-unei-masini-de-politie---2534269.html>

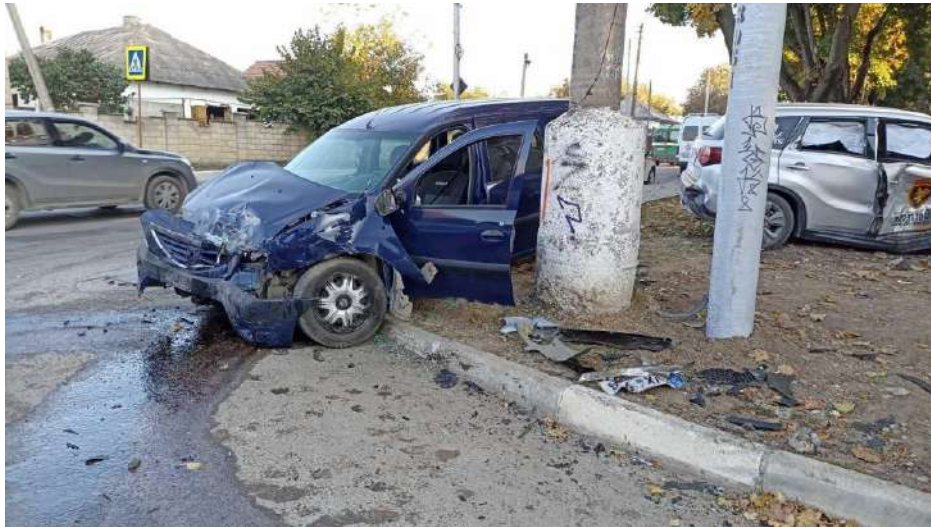
Figure 8: Car crash on Calea Iesilor str. on 30.09.2021. Source: <https://www.tvn.md/ro/fotovideo-accident-violent-in-balti-cu-implicarea-unei-masini-de-paza-doua-persoane-au-ajuns-la-spital/>

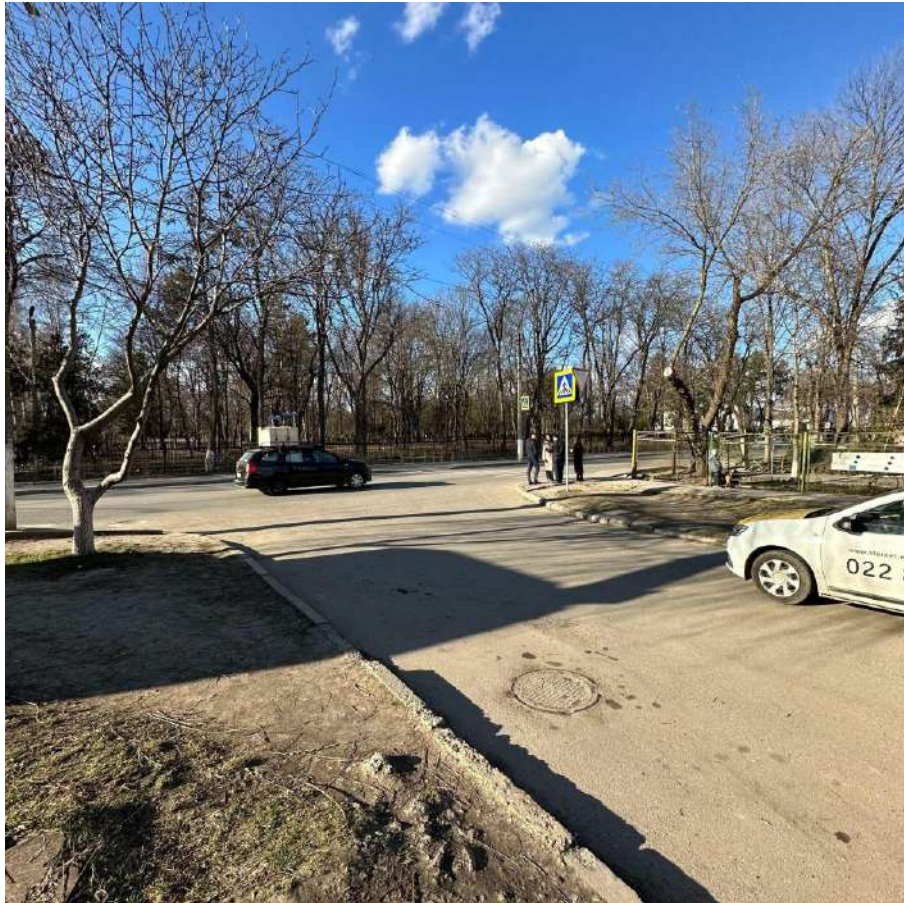
A particular situation is at the intersection of Calea Iesilor street and Belousov, where is present one of the main pedestrian crossings linking the two high schools and public transport stations on Calea Iesilor.

Figure 9: Balti, intersection of Calea Iesilor and Belousov streets

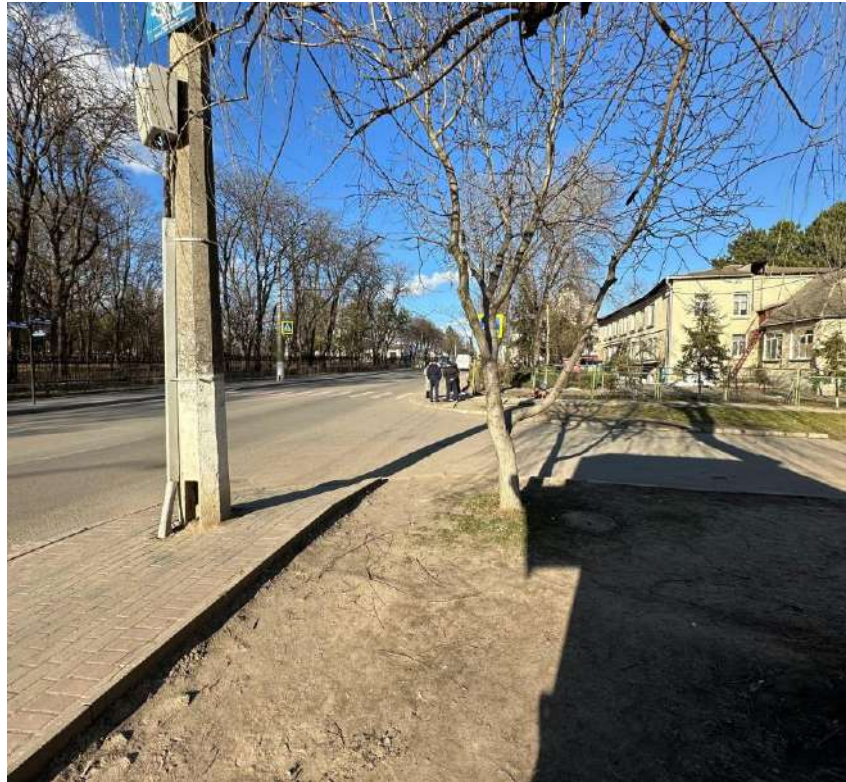
At this location, on Belousov street the pedestrian crossing is missing and the pedestrian infrastructure is very damaged and inaccessible. The pedestrians making their way from trolleybus stop to "B. P. Hasdeu" lyceum have to cross the Belousov street exposing themselves to the cars that are turning to Calea Iesilor street and walking right on the carriageway.

Figure 10: Balti, intersection of Calea Iesilor and Belousov streets

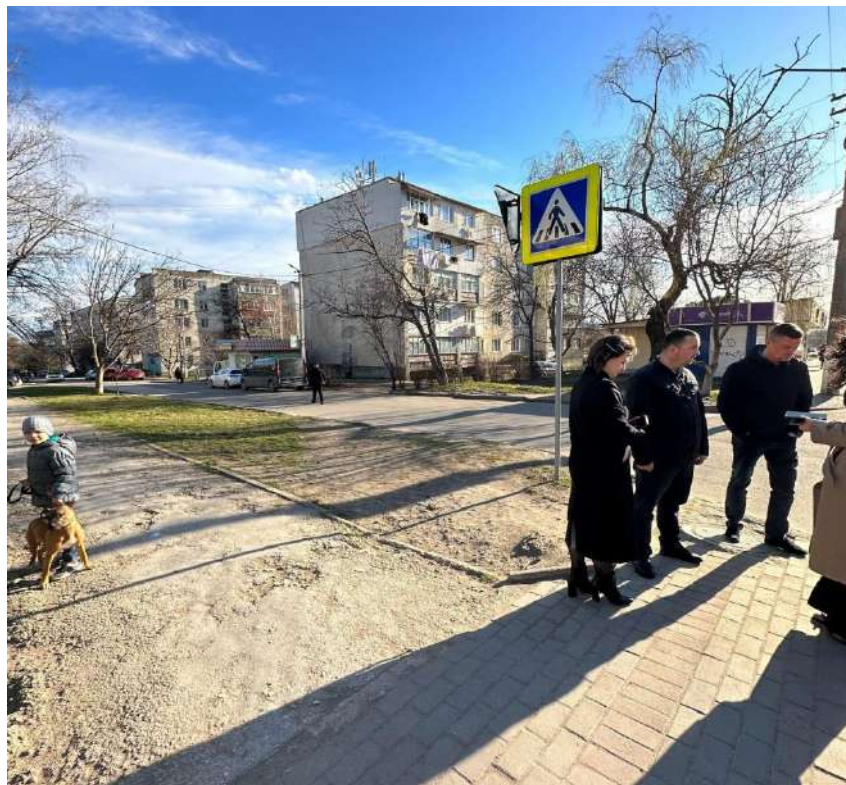
Additionally, there is very narrow and broken pavement which makes people walk through green areas, creating the desired paths.

Figure 11: Balti, intersection of Calea Iesilor and Belousov streets. Source: ACM

The pedestrian crossing at the intersections of Calea leșilor and Belousov streets, near the “Stefan cel Mare” and ”B.P.Hasdeu” lyceums in Balti was secured through tactical urbanism interventions, namely:

- School zone warning signs installation, signs and markings to guide drivers and warn them of their proximity to a school;
- 30 km/h speed limit introduction;
- Redesign of the Calea Iesilor/Belousov intersection with the addition of a pedestrian crossing on Belousov street and pavement improvement;
- Pedestrian guardrails installation on both streets in the crossing perimeter.

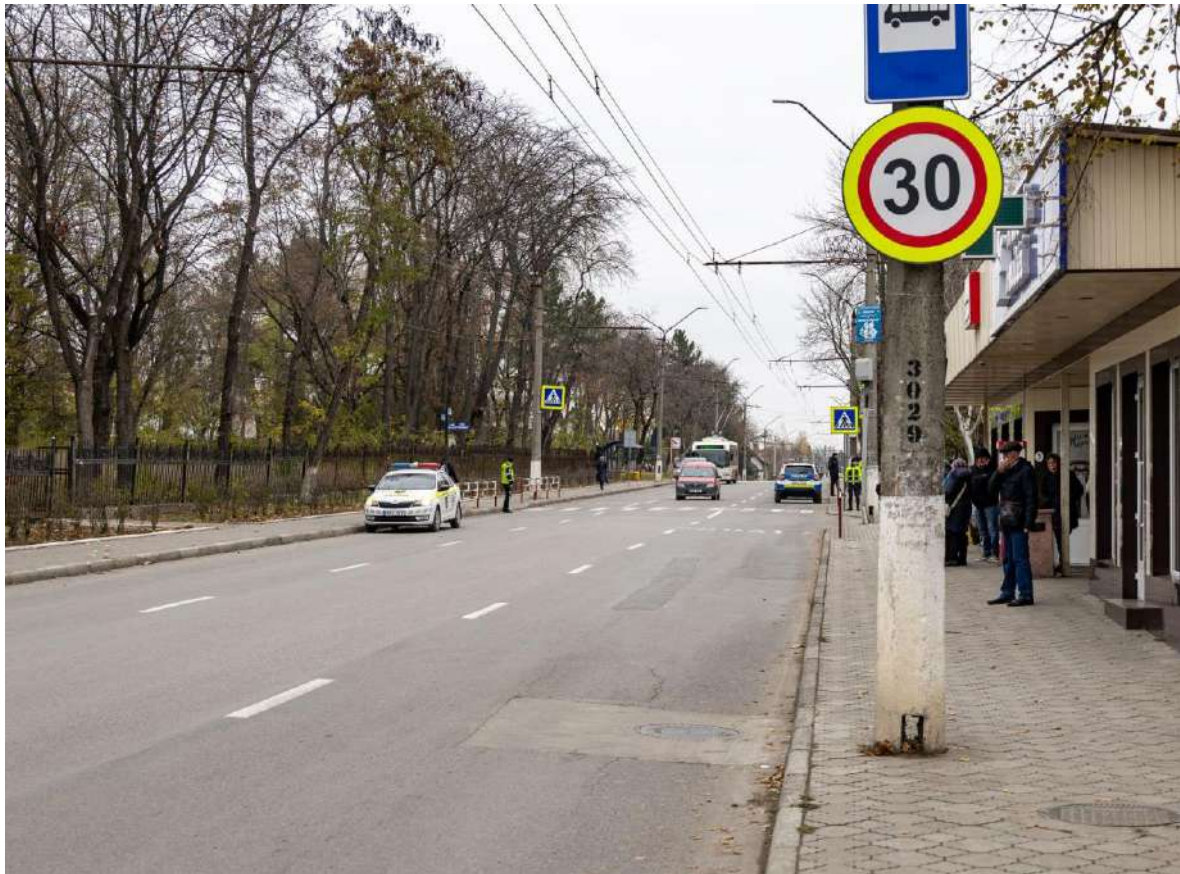
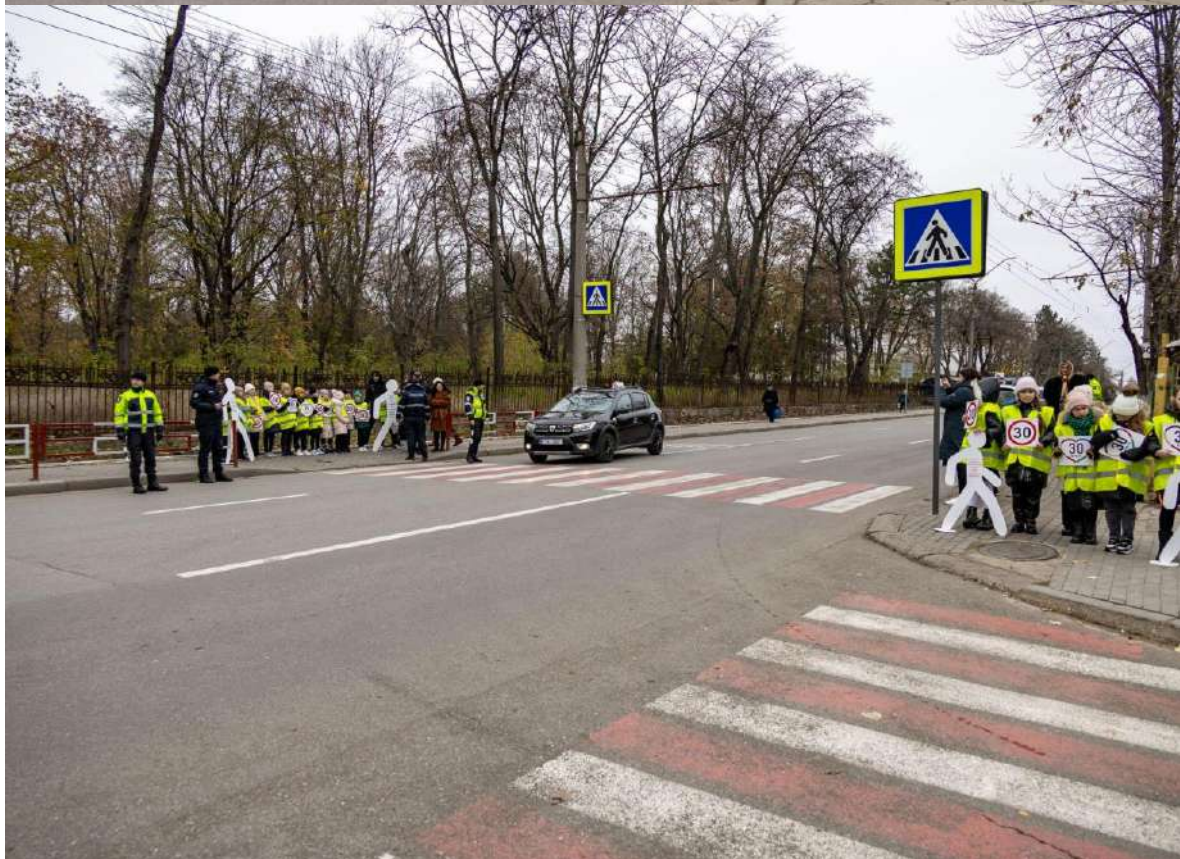
Figure 13: Balti, Calea Iesilor street after interventions. Source: ACM

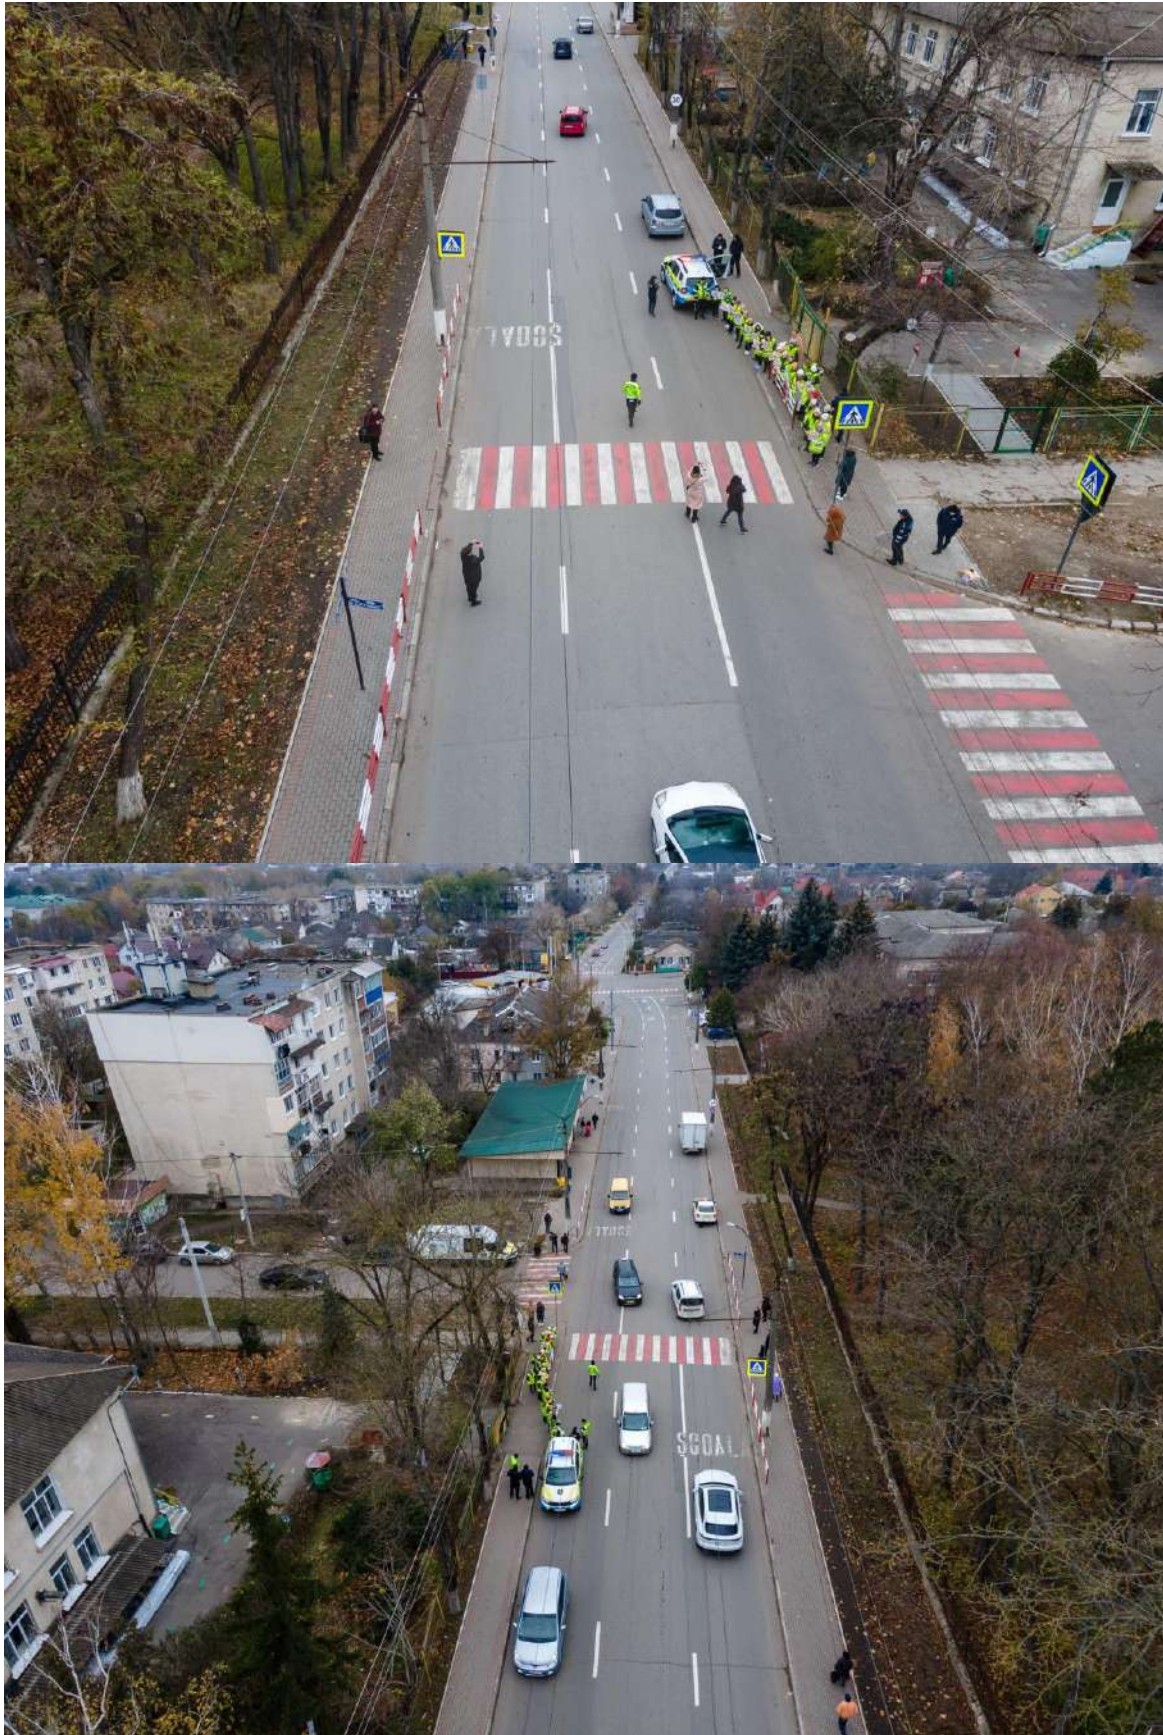
Figure 14: Balti, Calea Iesilor street after interventions. Source: ACM

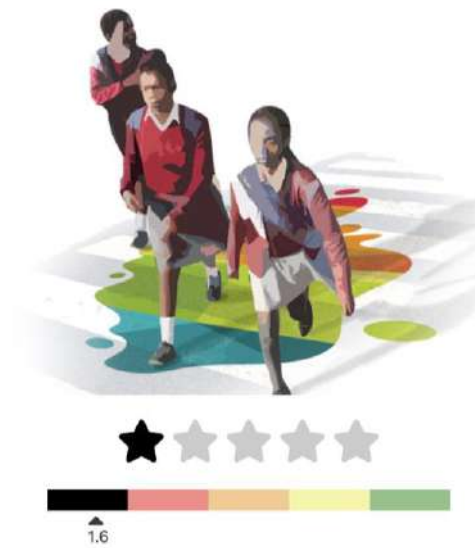
Figure 15: The safety level of the location according to the Star Rating for Schools tool. Before intervention. Source: iRAP Demonstrator tool, ACM.

As a result of the provided interventions the Star Rating for Schools of the location assessed location on Calea Iesilor street in Balti has improved from 1.6 to 4.4 stars (Figure 16).

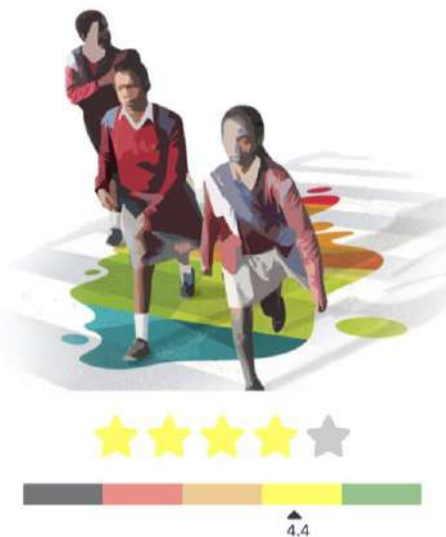
Figure 16: The safety level of the location according to the Star Rating for Schools tool. After intervention. Source: iRAP Demonstrator tool, ACM.

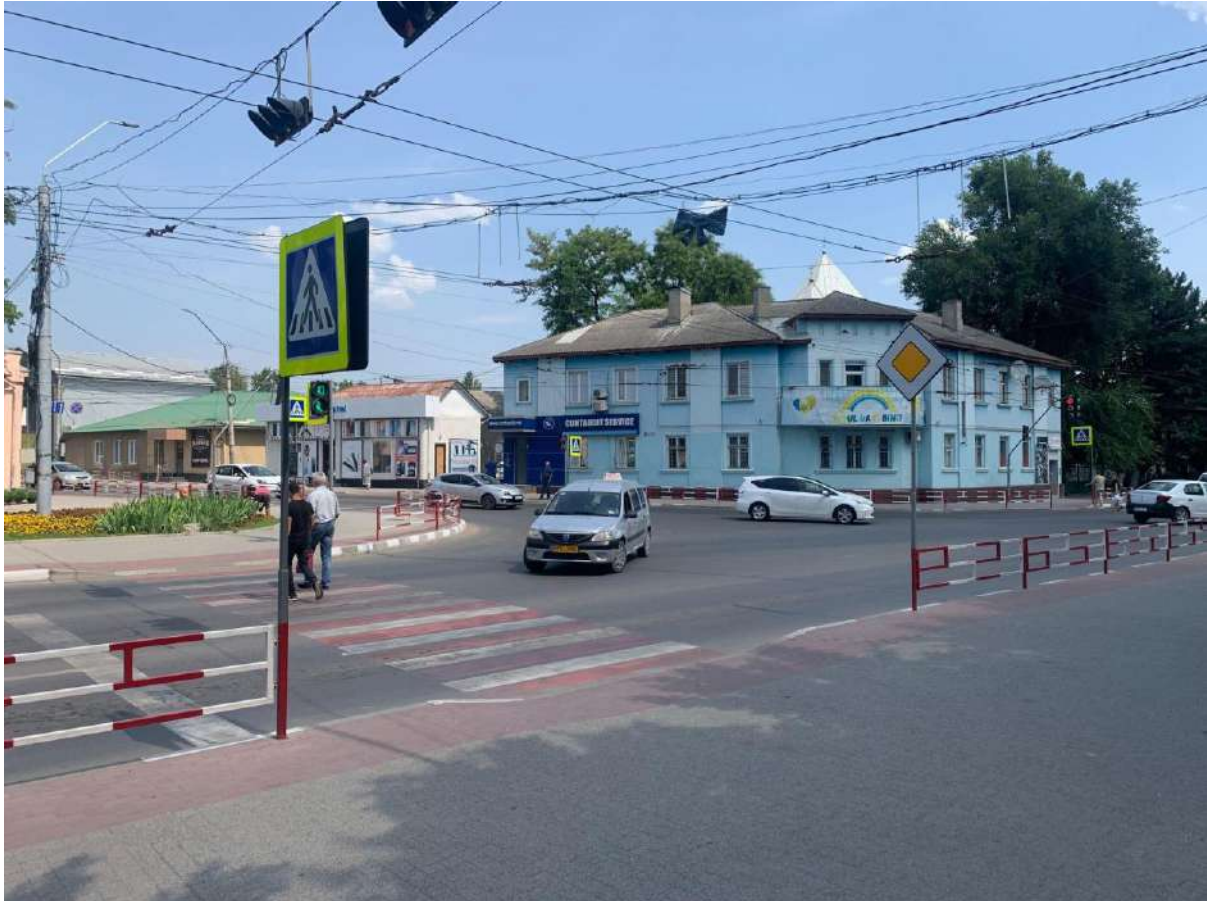
In this area the intersection of Stefan cel Mare and Decebal streets represent a T-shaped intersection with pedestrian crossings, traffic lights and safety barriers, which make it safe enough for pedestrians.

Figure 18: Balti, intersection of Stefan cel Mare and Decebal streets

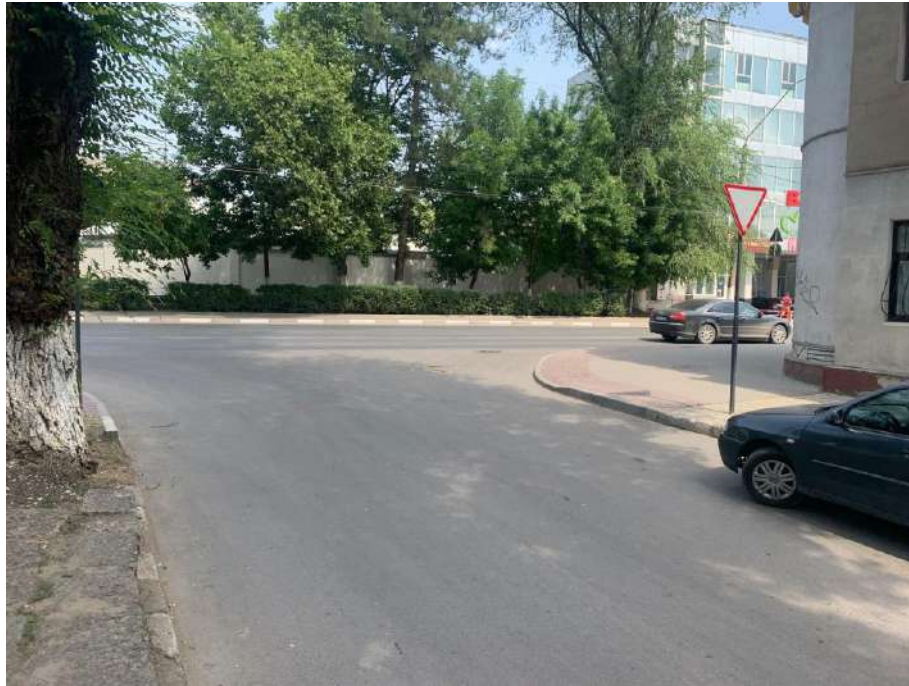
However, the intersection of Stefan cel Mare street and Hotin does not have a marked and signed pedestrian crossing. This makes the intersection less safe, and sometimes drivers do not give priority to pedestrians.

Figure 19: Balti, intersection of Stefan cel Mare and Hotin streets

- School zone warning signs installation, signs and markings to guide drivers and warn them of their proximity to a school.
- 30 km/h speed limit introduction on Stefan cel Mare and Hotin streets.
- Raised pedestrian crossing at the intersections of Stefan cel Mare and Hotin streets.

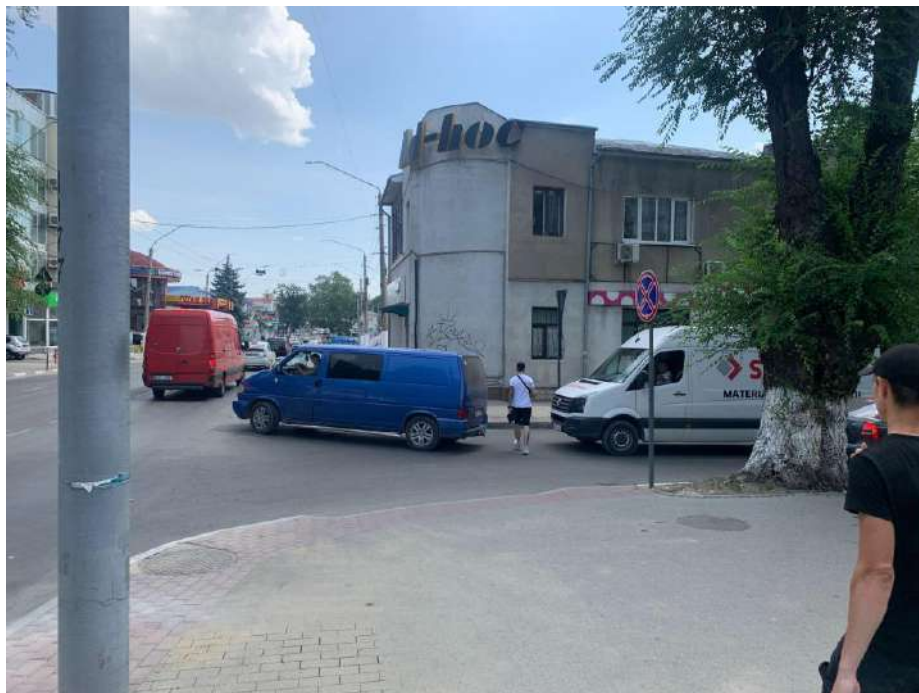
Figure 20: Balti, intersection of Stefan cel Mare and Hotin streets

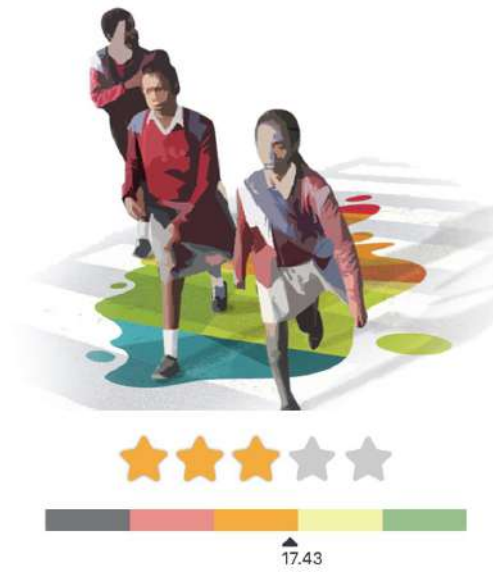
Figure 21: The safety level of the area according to the Star Rating for Schools tool. Existing situation.
Source: iRAP Demonstrator tool, ACM

As a result of the proposed interventions implementation the Star Rating for Schools at the assessed location will improve to 5 stars.

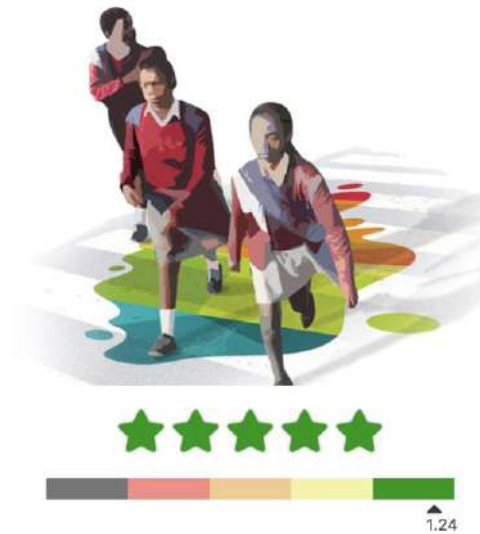
Figure 22: The safety level of the area according to the Star Rating for Schools tool. After interventions. Source: iRAP Demonstrator tool, ACM

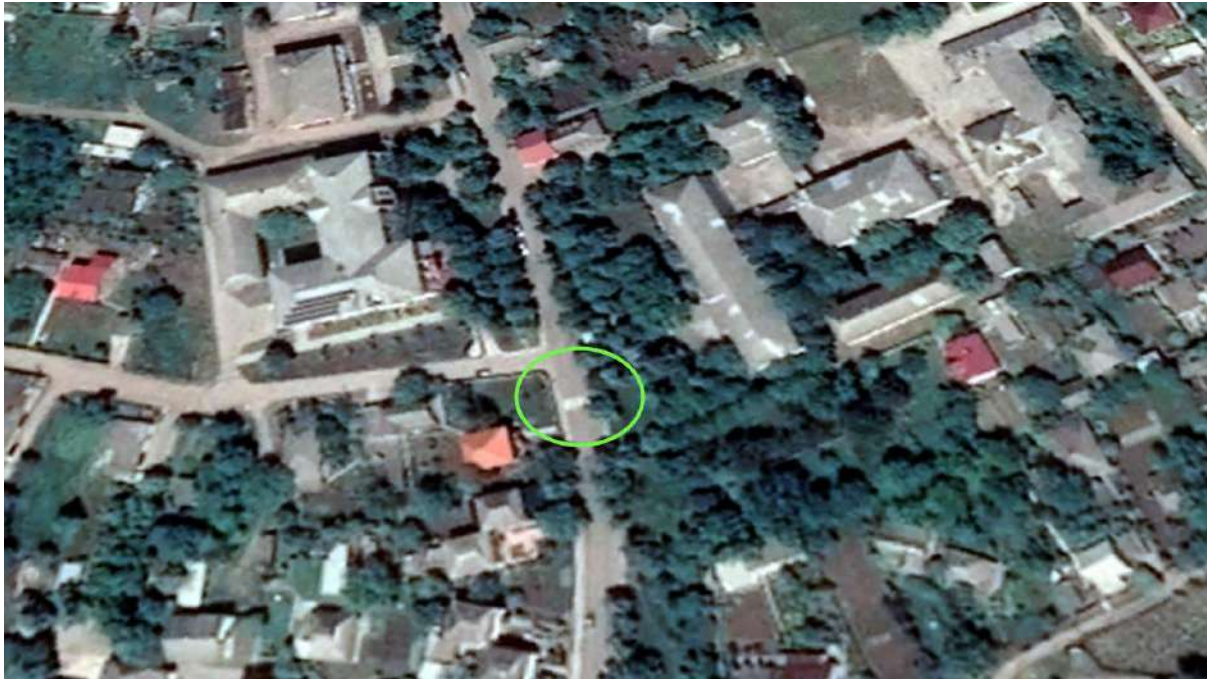
At the indicated location, only one marked pedestrian crossing is in place, right in front of the "Dimitrie Cantemir" school, at the intersection of Nicolae Testemitanu and Mihail Frunze Street.

Figure 25: Pedestrian crossing in "Dimitrie Cantemir" school zone, Singerei. Source: Google Maps

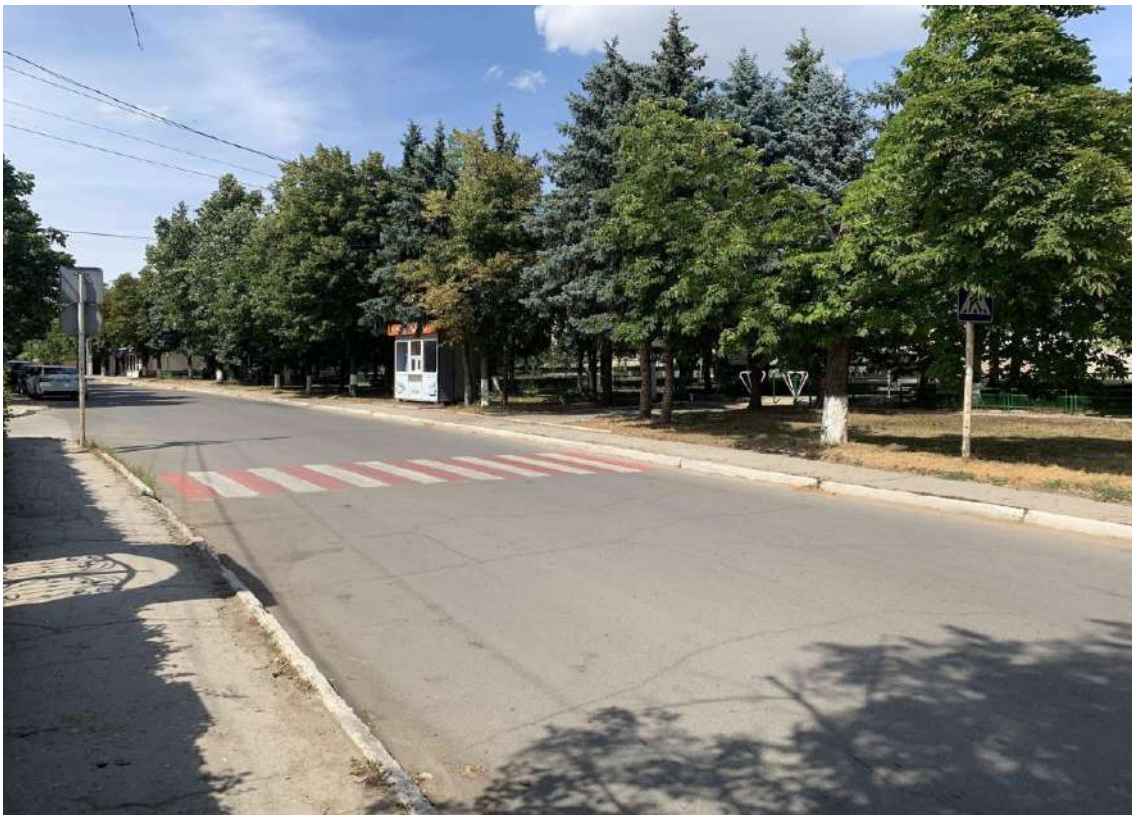
The assessment established that Nicolae Testemitanu Street has two lanes of traffic in both directions. Each lane is 3,5 metres wide, forming a carriageway exceeding 7 metres wide.

Figure 26: Pedestrian crossing in "Dimitrie Cantemir" school zone, Singerei. Source: ACM

The pedestrian crossing has no access ramps, which makes it more difficult to access. Parking is not properly regulated and during peak hours, the pedestrian crossing has reduced visibility due to parallel parked cars on the road.

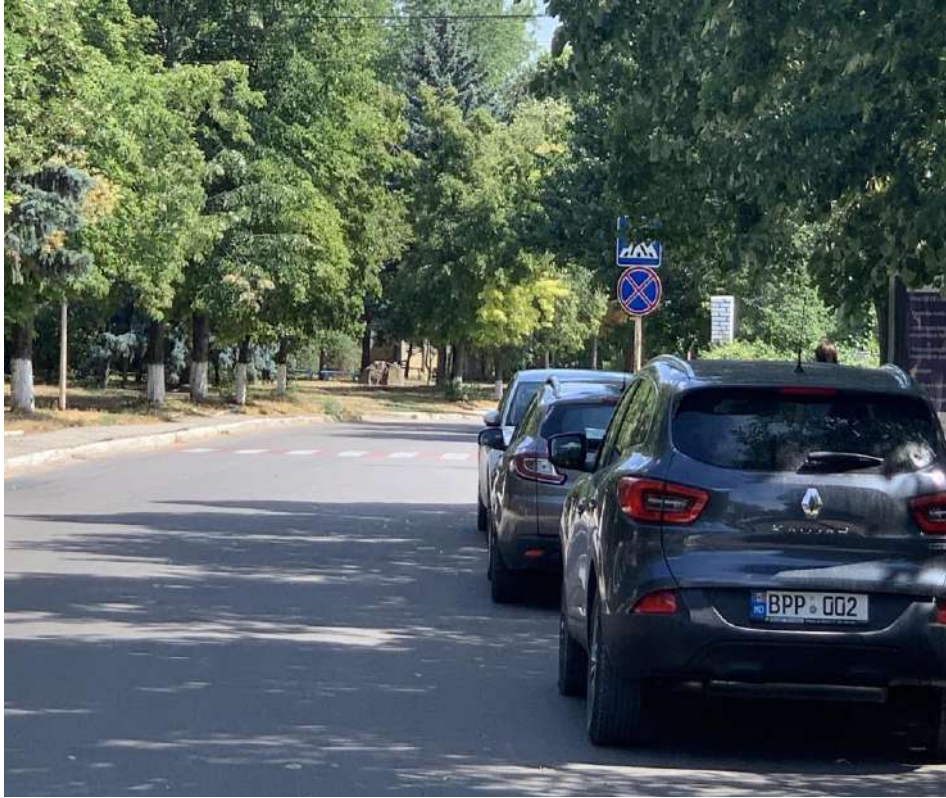
Figure 27: Parking at pedestrian crossing in "Dimitrie Cantemir" school zone, Singerei

- narrowing the pedestrian crossing with bollards;
- preventing parking in the area 5 meters from the crossing by means of plastic bollards;
- applying reflective markings, inscription "SCHOOL" and coloured paint along the sidewalk;
- installation of traffic signs (including 30 km/h limit, "Attention, children", "Pedestrian crossing) and construction of access slopes from the sidewalk.

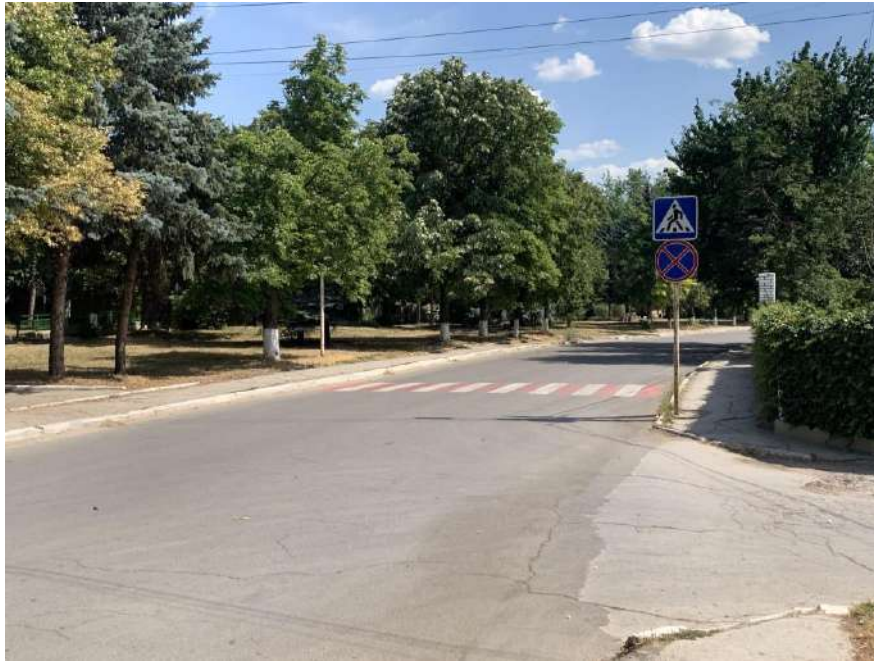
In this area, Testemitanu Street forms a curve. Parking near the pedestrian crossing and the lack of traffic calming elements generate an increased risk for pedestrians crossing the street at this location.

Figure 28: Pedestrian crossing in "Dimitrie Cantemir" school zone, Singerei

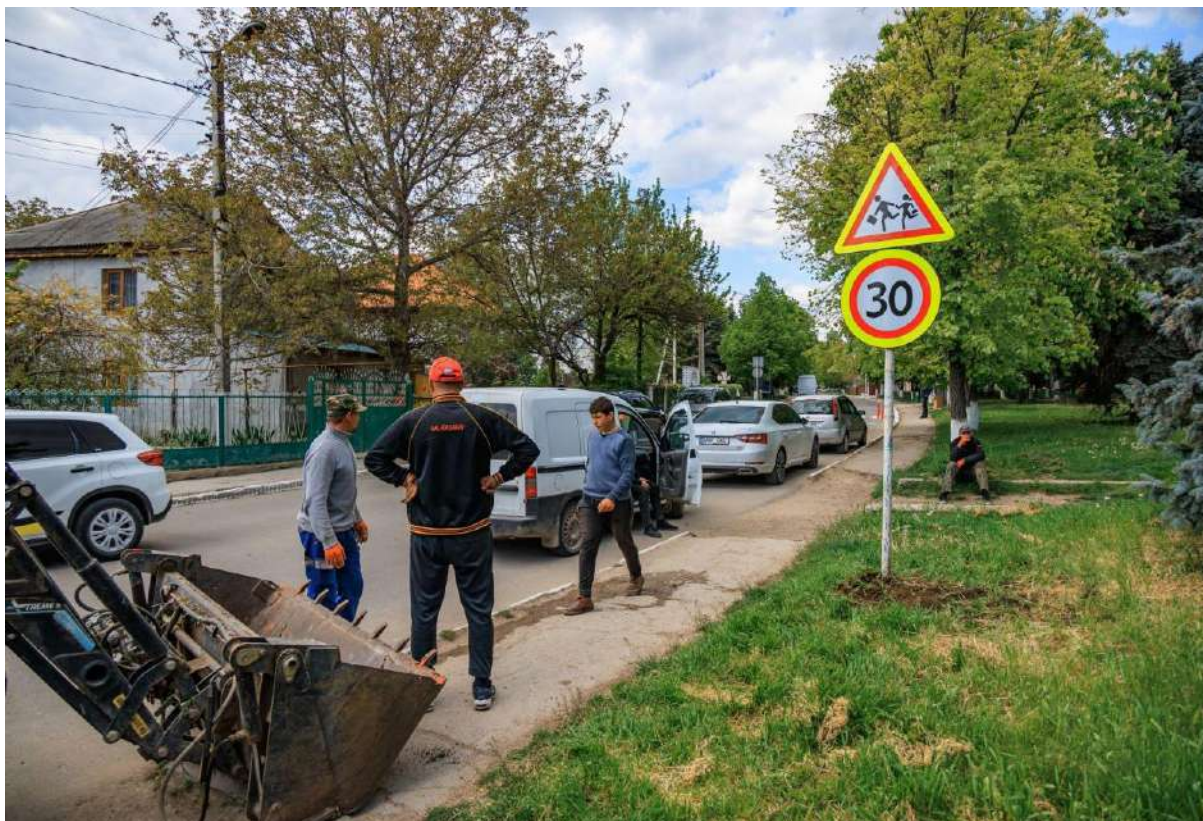
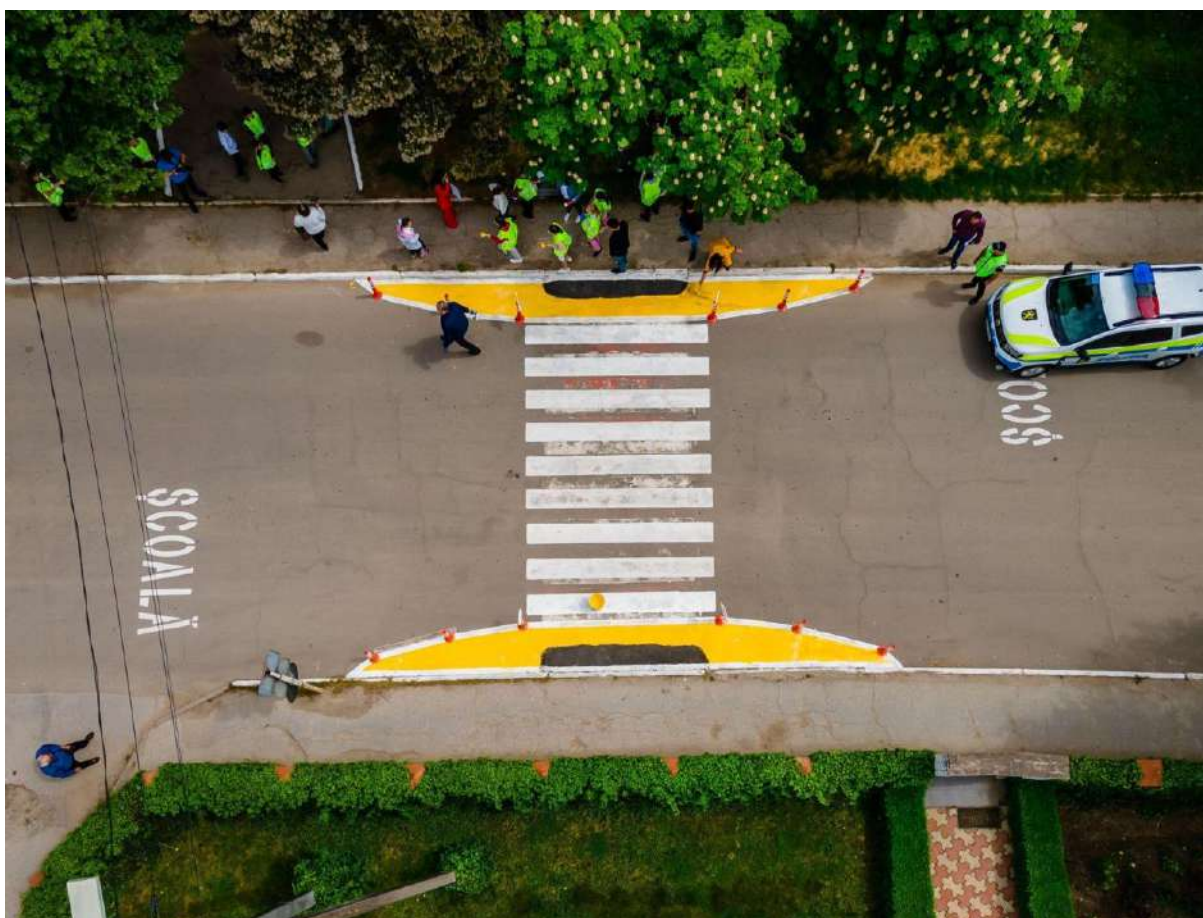
Following the intervention, the security rating of the pedestrian crossing, assessed according to the "Star Rating" methodology, increased from three stars to four stars, due to the reduction of operating traffic speed and the improvement of the visibility and accessibility of the pedestrian crossing.

Figure 30: Pedestrian crossing in "Dimitrie Cantemir" school zone, Singerei, after intervention. Source:

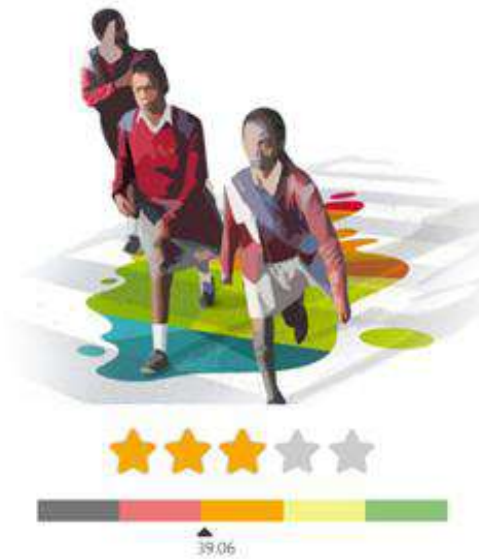
Before intervention

Operating speed: 60 km/h

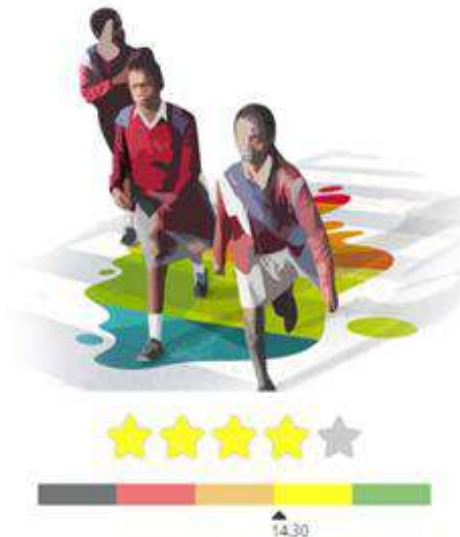
After intervention

Operating speed: 35 km/h

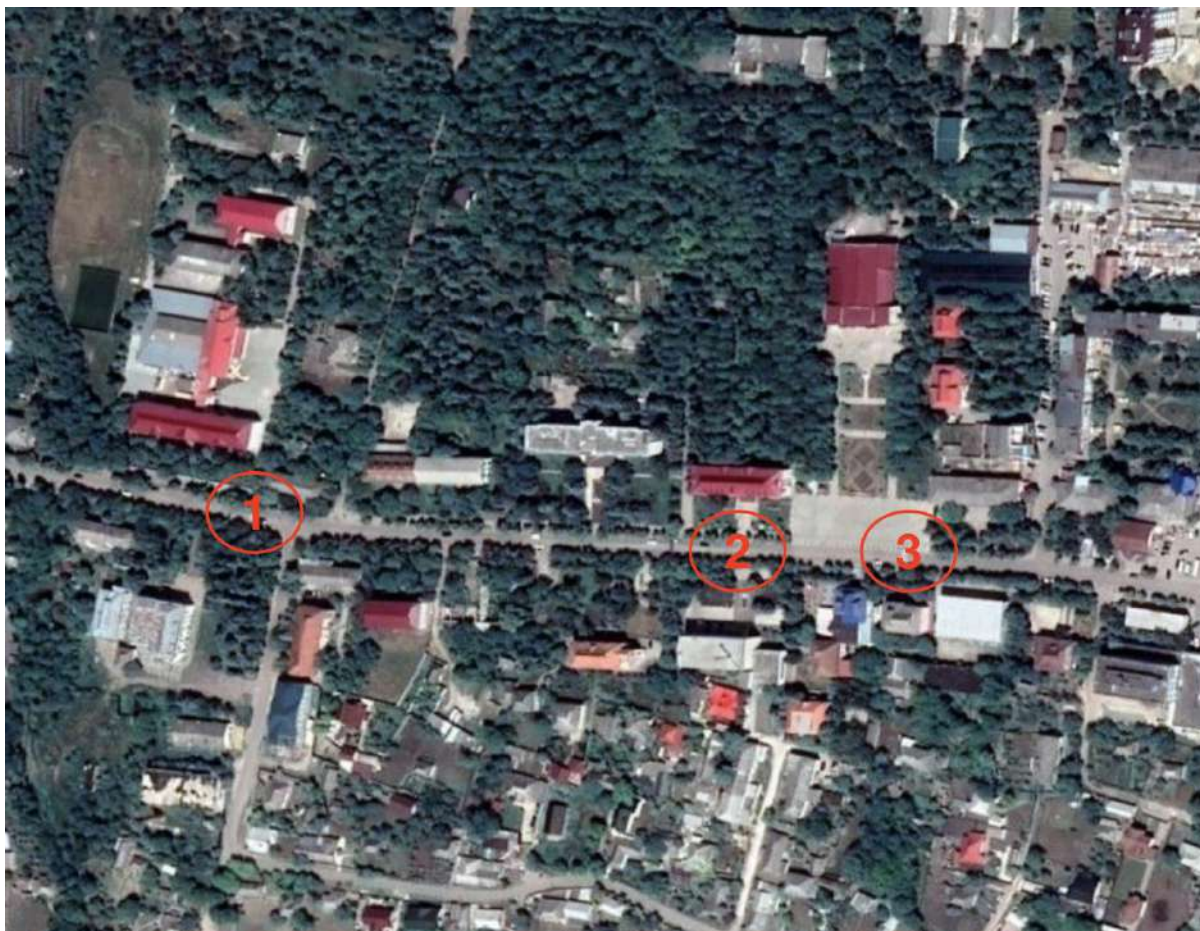
Independentei street is a two-lane street, one in each way. Each lane is 4 metres wide, leaving enough space for parking on each side. On a span of 550 metres there are three crosswalks, one in front of each education institution.

Figure 32: Location of crosswalks in assessed school zone in Singerei

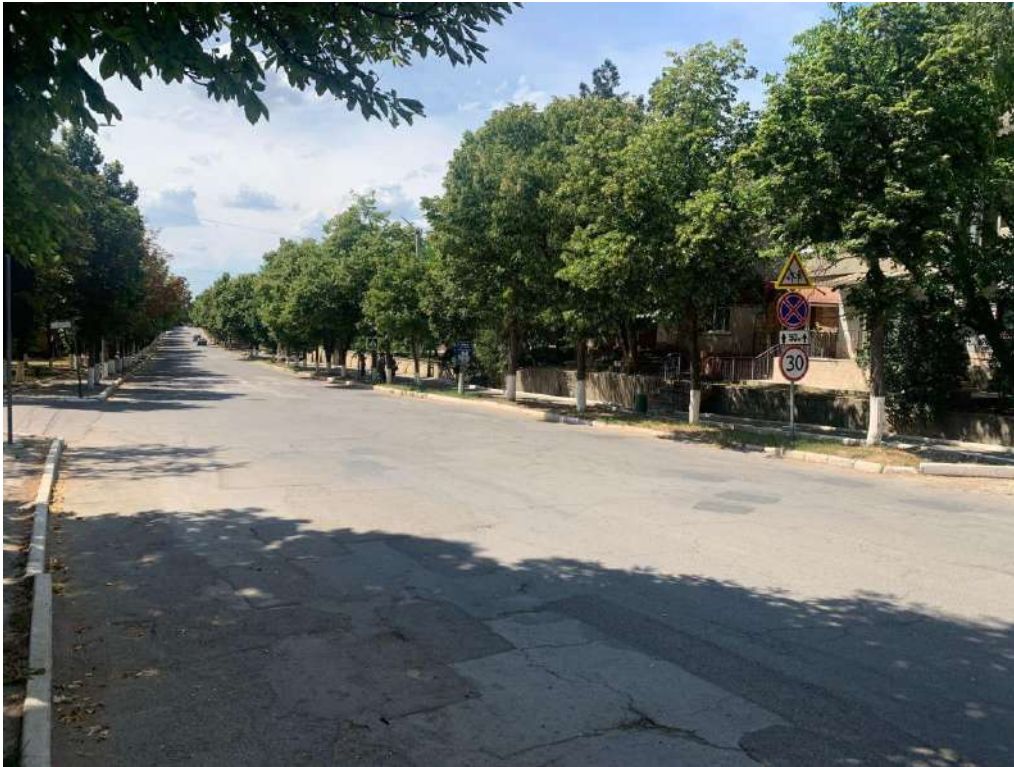
The surface on the street is degraded and the marking is almost invisible. However the crosswalks is better than the rest of the marking and is renovated each year.

The portion of the street in front of the "Mihai Eminescu" and "Olimp" lyceums has a 30 km/h speed limit.

Figure 33: 30 km/h speed limit on Independentei street in Singerei
