STAR RATING
FOR SCHOOLS

Safe crossings - safe journeys project

**School zone assessment in 3 localities:
Balti, Singerei and Ungheni municipalities**

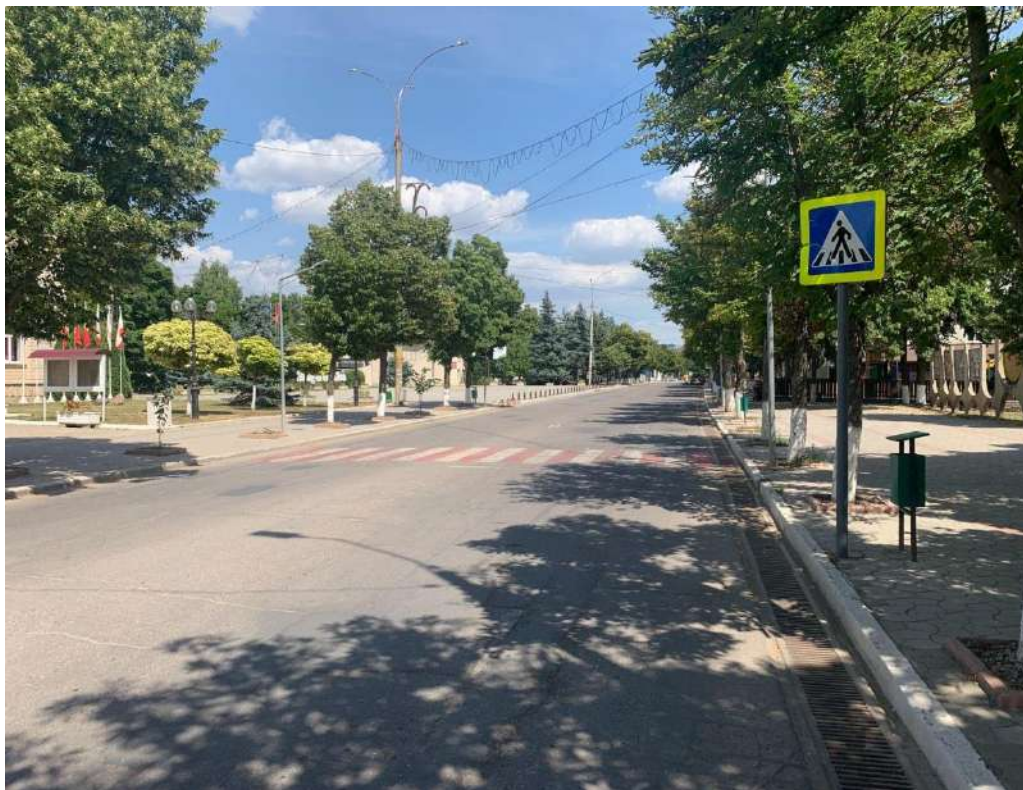
Figure 34: Crosswalk near "M. Eminescu" lyceum in Singerei

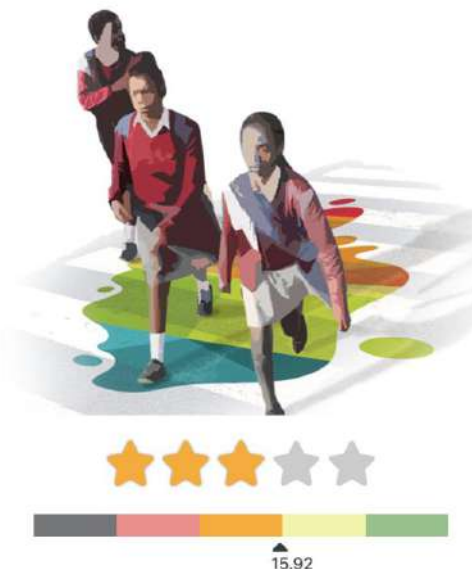
Figure 35: The safety level of the area according to the Star Rating for Schools tool before intervention. "M. Eminescu" and "Olimp" school zone, Singerei.

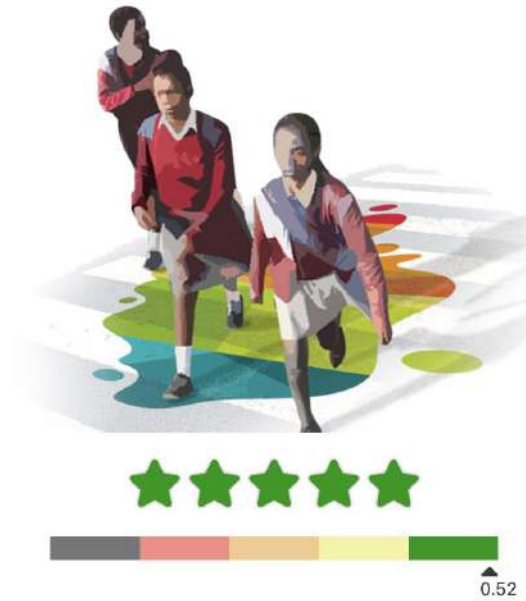
Figure 36: The safety level of the area according to the Star Rating for Schools tool after proposed intervention. "Eminescu" and "Olimp" school zone, Singerei.

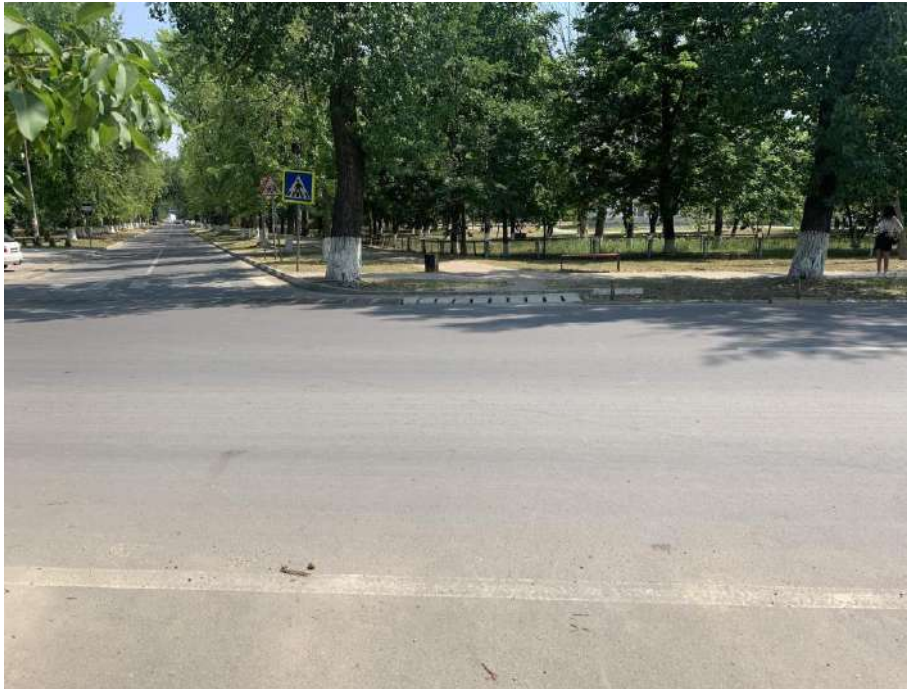
Figure 40: Ungheni, Decebal street, area of "Alexandr Pushkin" Lyceum

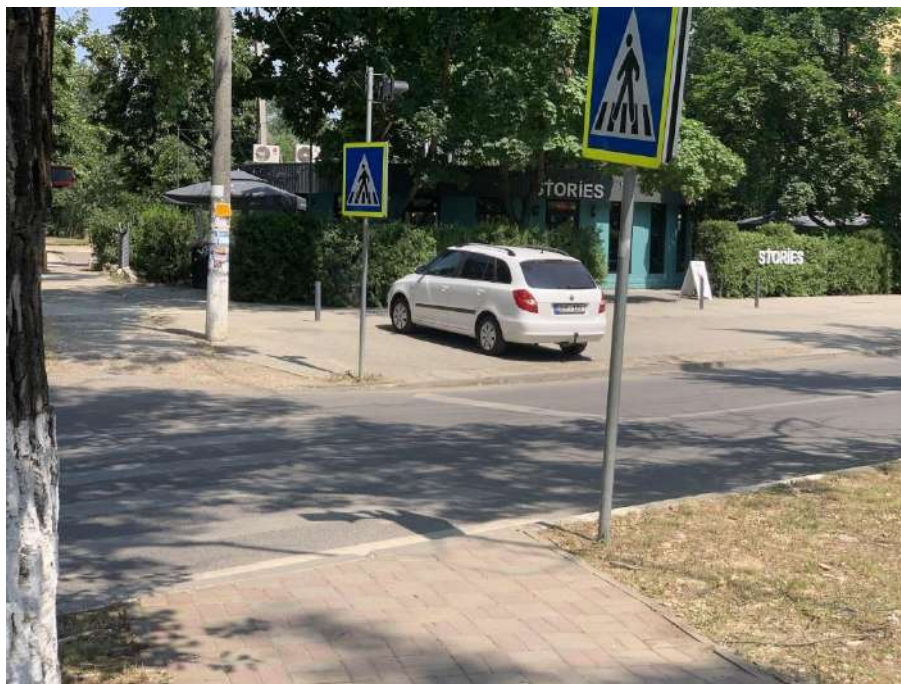
Figure 41: Ungheni, Decebal and Bernardazzi street, area of "Alexandr Pushkin" Lyceum

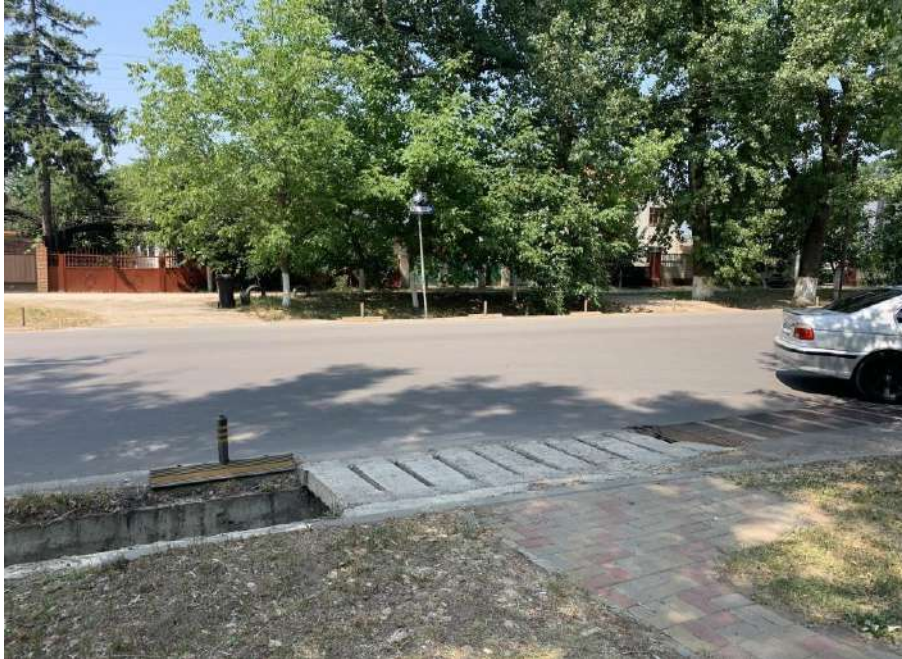
Figure 42: Ungheni, Decebal and Bernardazzi street, area of "Alexandr Pushkin" Lyceum

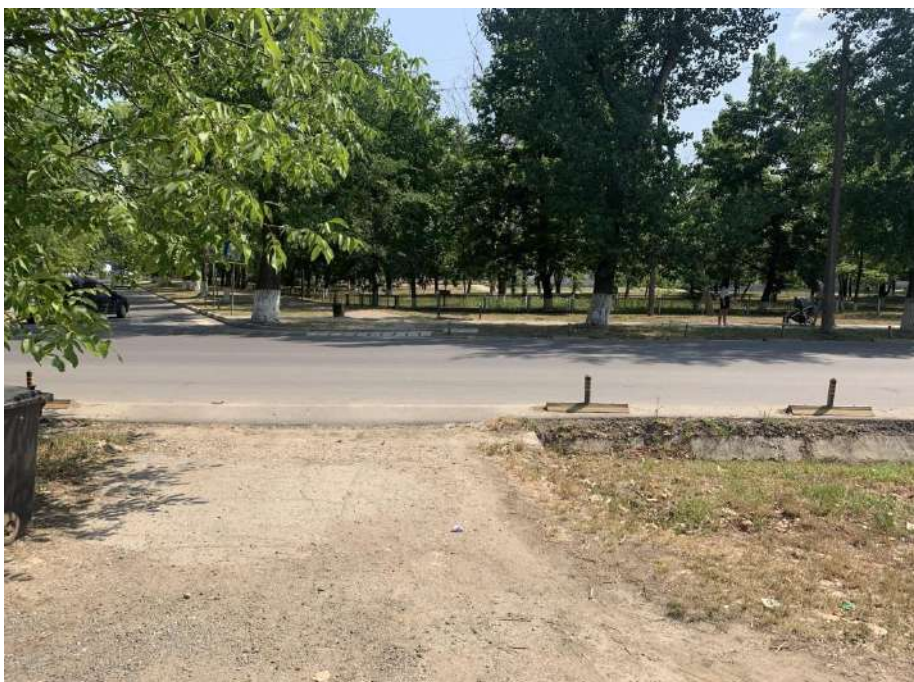
Figure 43: Ungheni, Decebal and Bernardazzi street, area of "Alexandr Pushkin" Lyceum. Source:

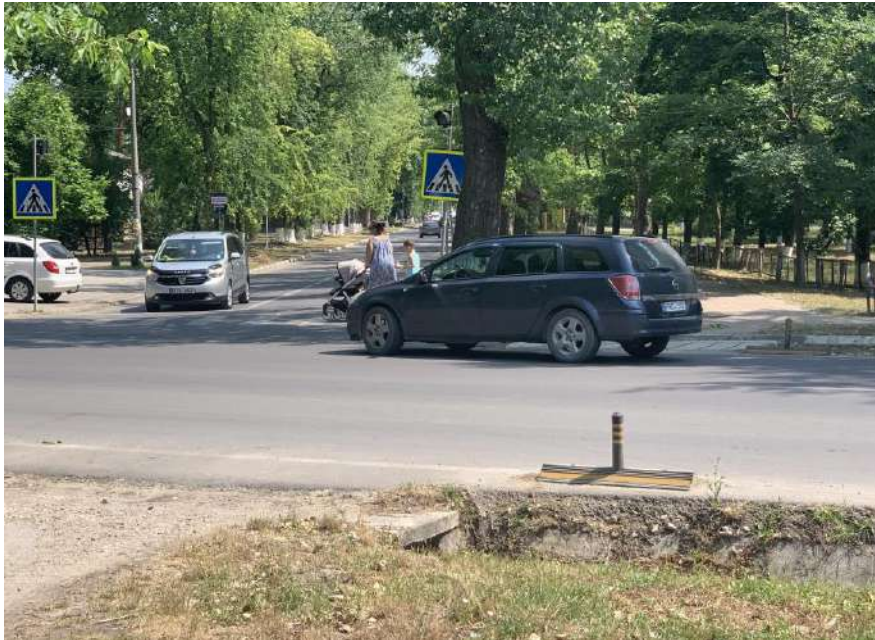
Figure 44: Ungheni, Decebal and Bernardazzi street, area of "Aleksandr Pushkin" Lyceum

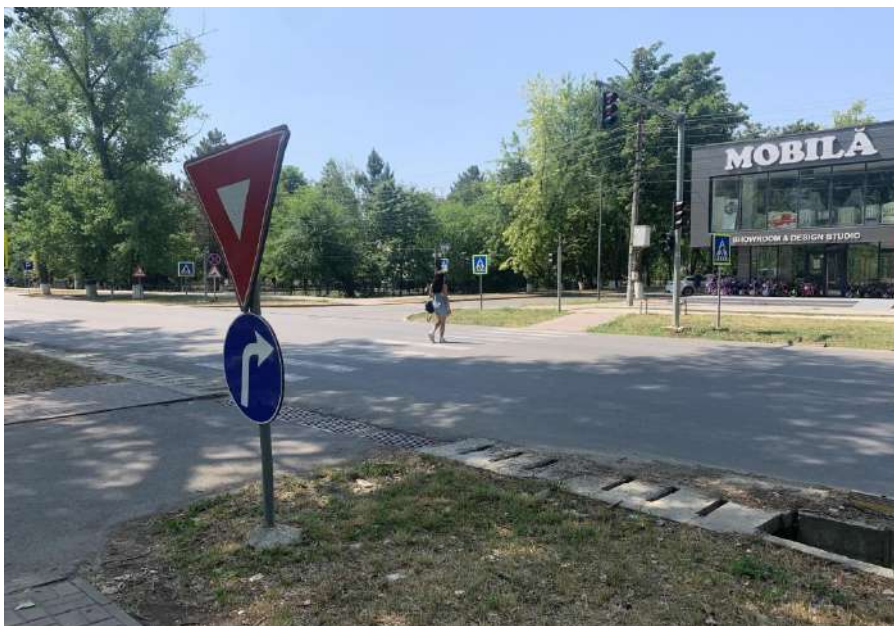
Figure 45: Ungheni, Decebal and Porumbescu street, area of "Alexandr Pushkin" Lyceum

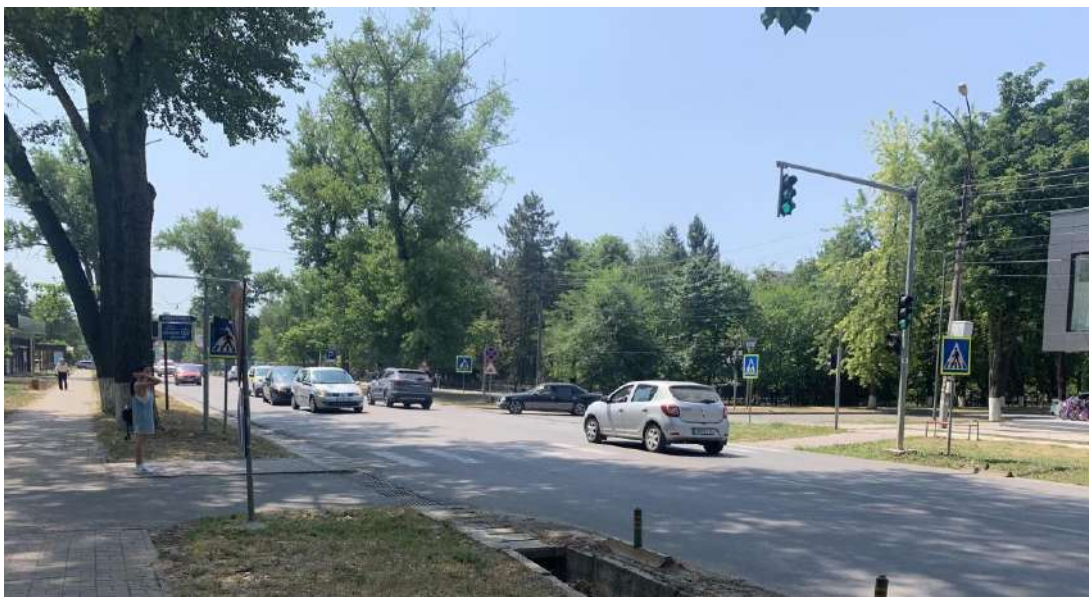
Figure 46: Ungheni, Decebal and Porumbescu street, area of "Alexandr Pushkin" Lyceum

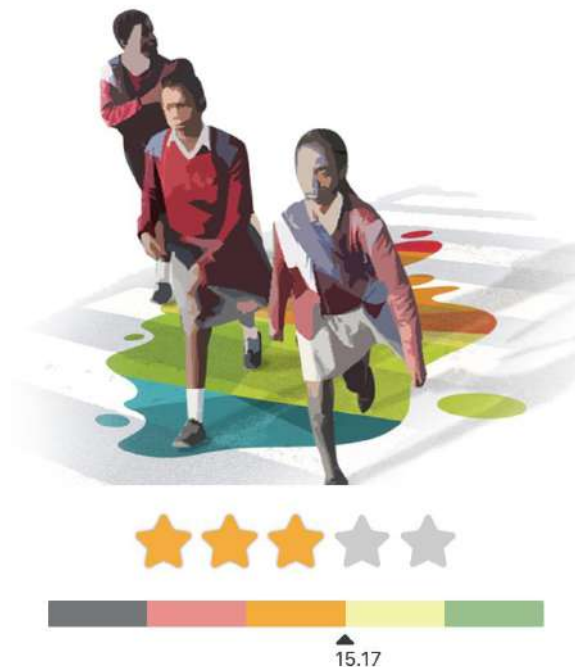
Figure 47: The safety level of the area according to the Star Rating for Schools tool. "Alexandr Pushkin" school zone, before, Ungheni.

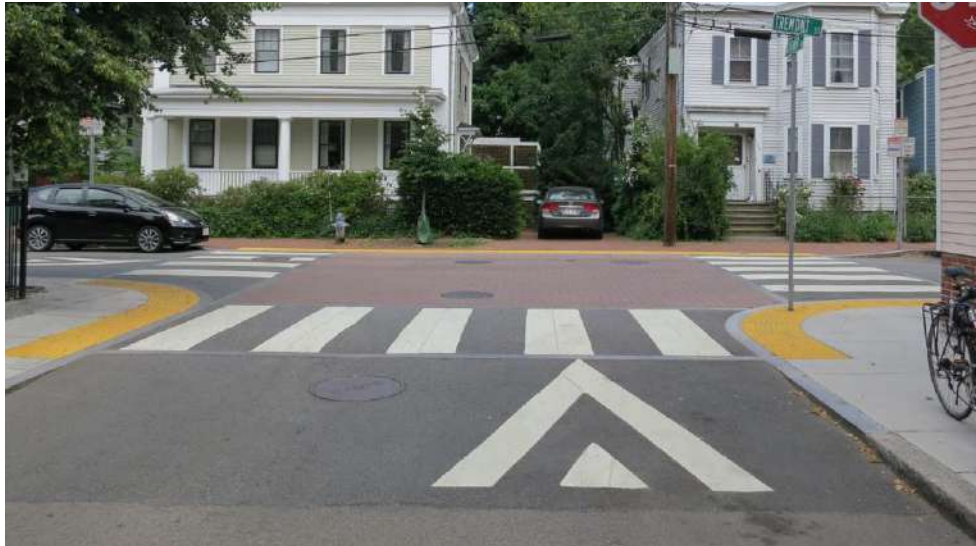
Figure 48: Example of raised pedestrian crossing. Source: Google photos

Decebal street		
Attribute	Before: 3 stars	After: 5 stars
Number of lanes	2	2
School Zone Warning	No school zone	Signs/Markings
Pedestrian crossings	Marked	Raised
Speed limit	50 km/h	30 km/h
Traffic lights	Present	Present
Traffic calming measures	No	Yes

As a result of proposed interventions the Star Rating for Schools will improve to 5 stars.

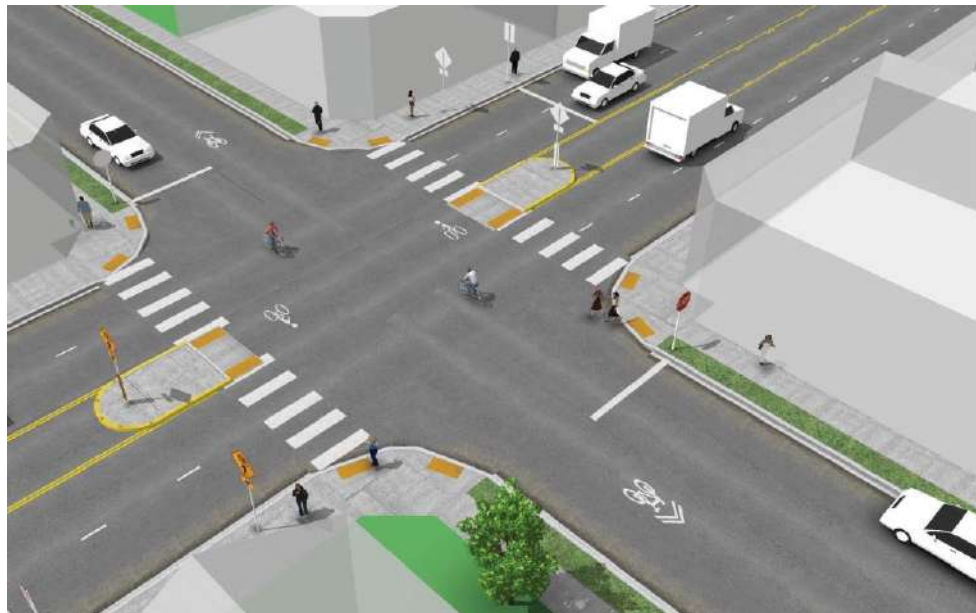
Figure 49: Example of refuge island at the intersection. Source: Google photos

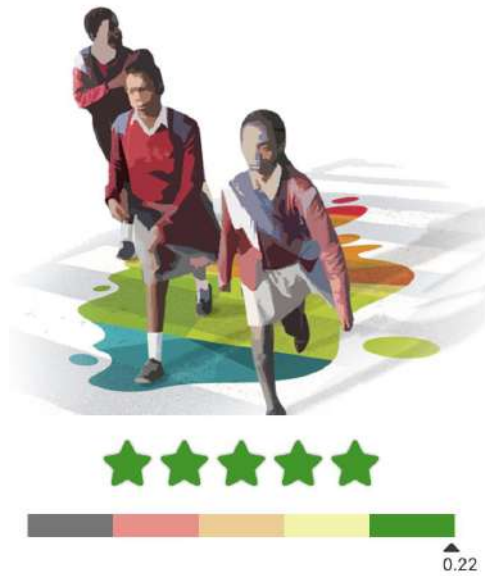
Figure 50: The safety level of the area according to the Star Rating for Schools tool. "Alexandr Pushkin" school zone, after improvements, Ungheni.

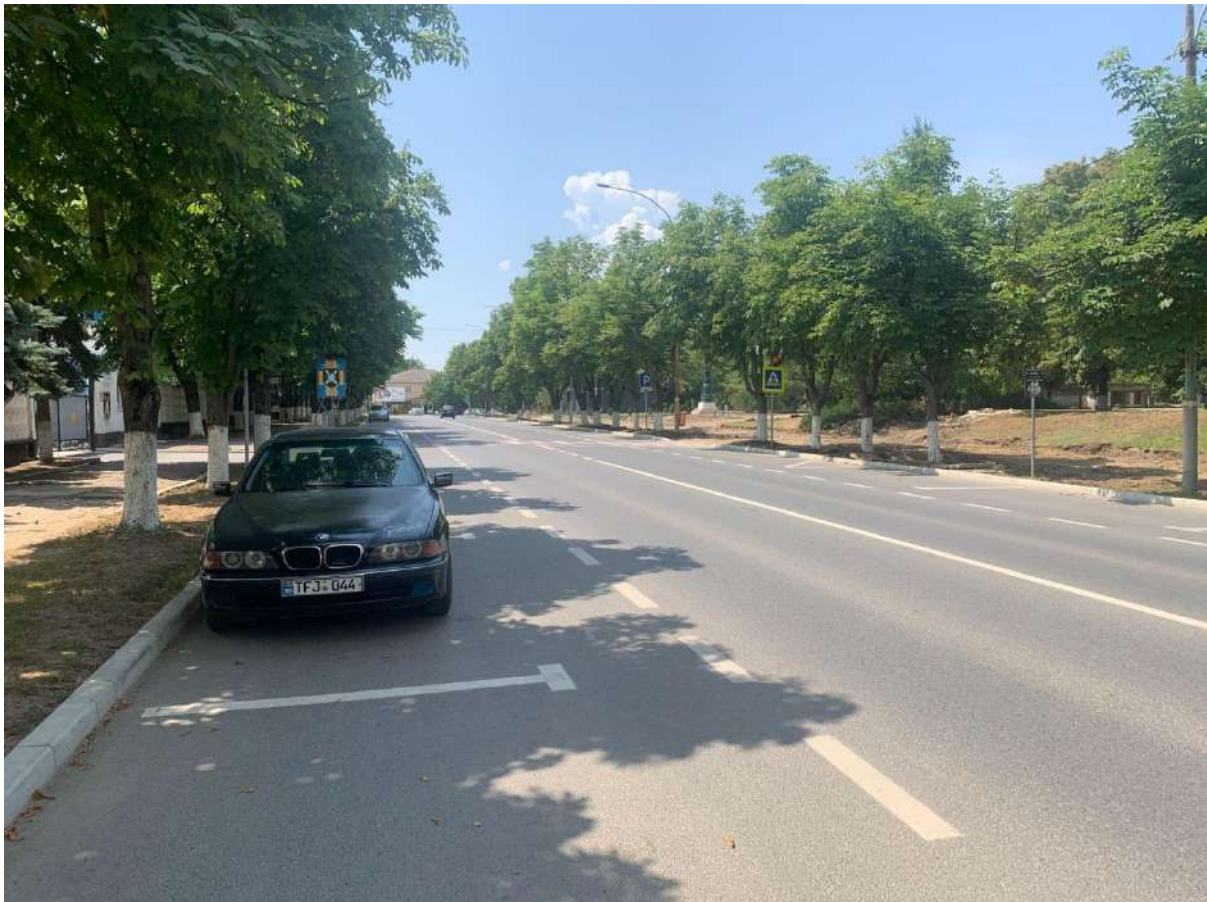
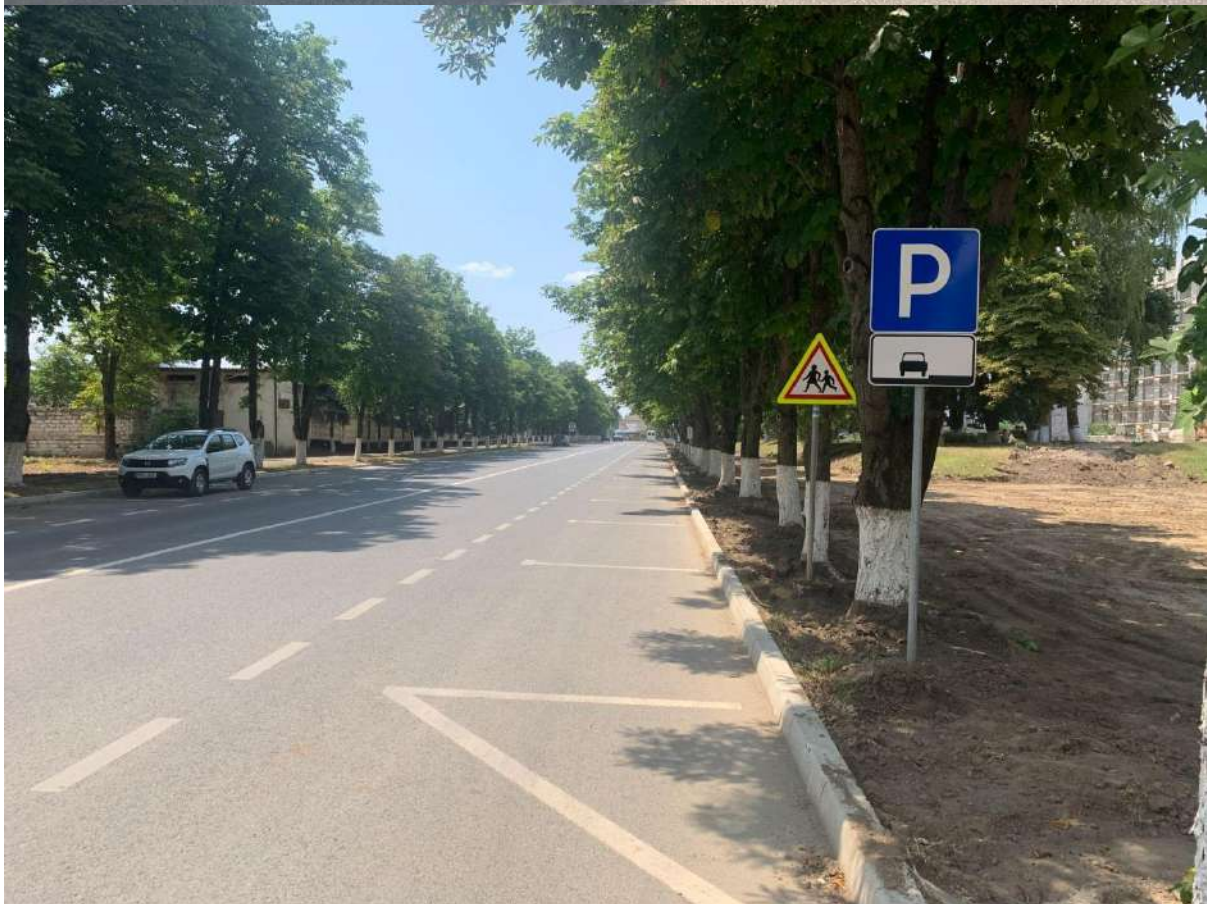
Figure 52: Parking mode, Nationala Street, Ungheni. Source: ACM

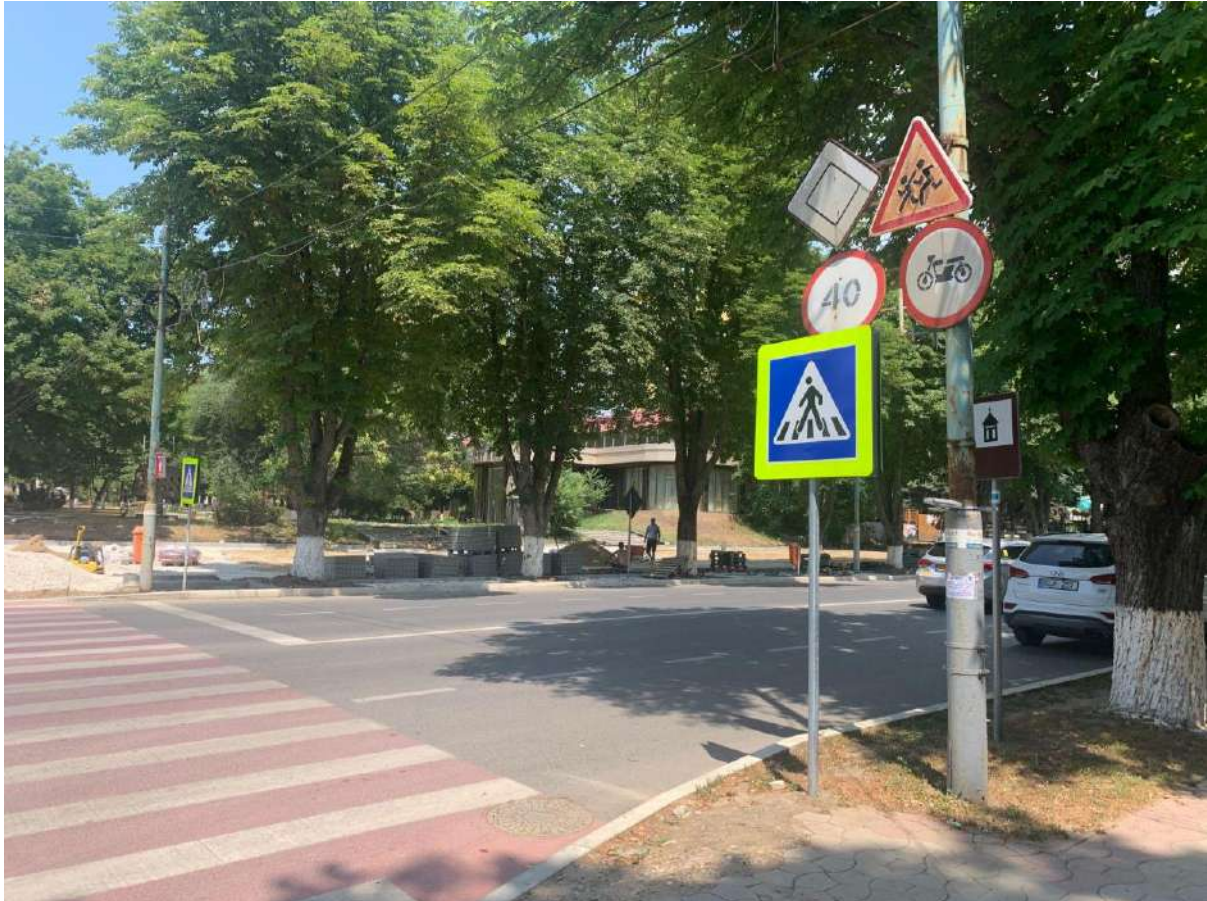
Figure 53: Pedestrian crossing on Nationala Street, school area, Ungheni. Source:ACM

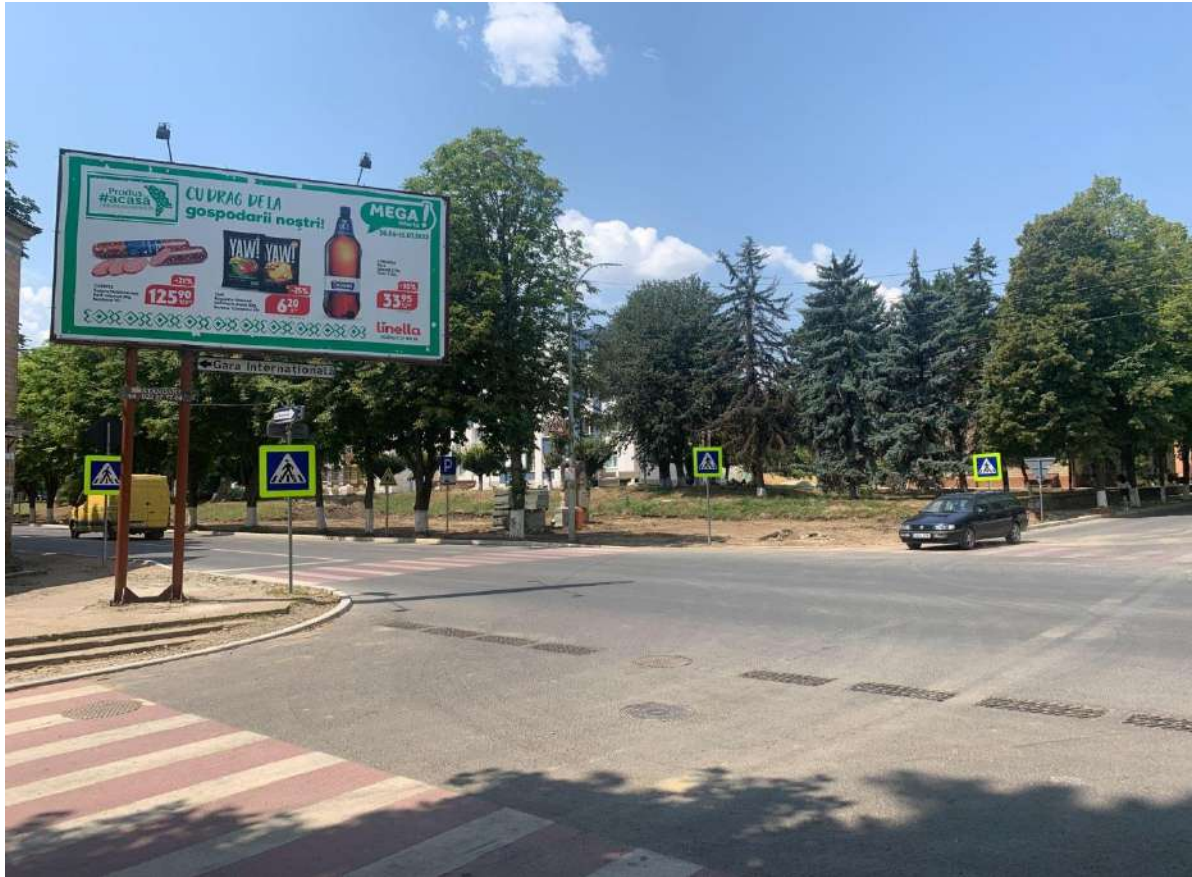
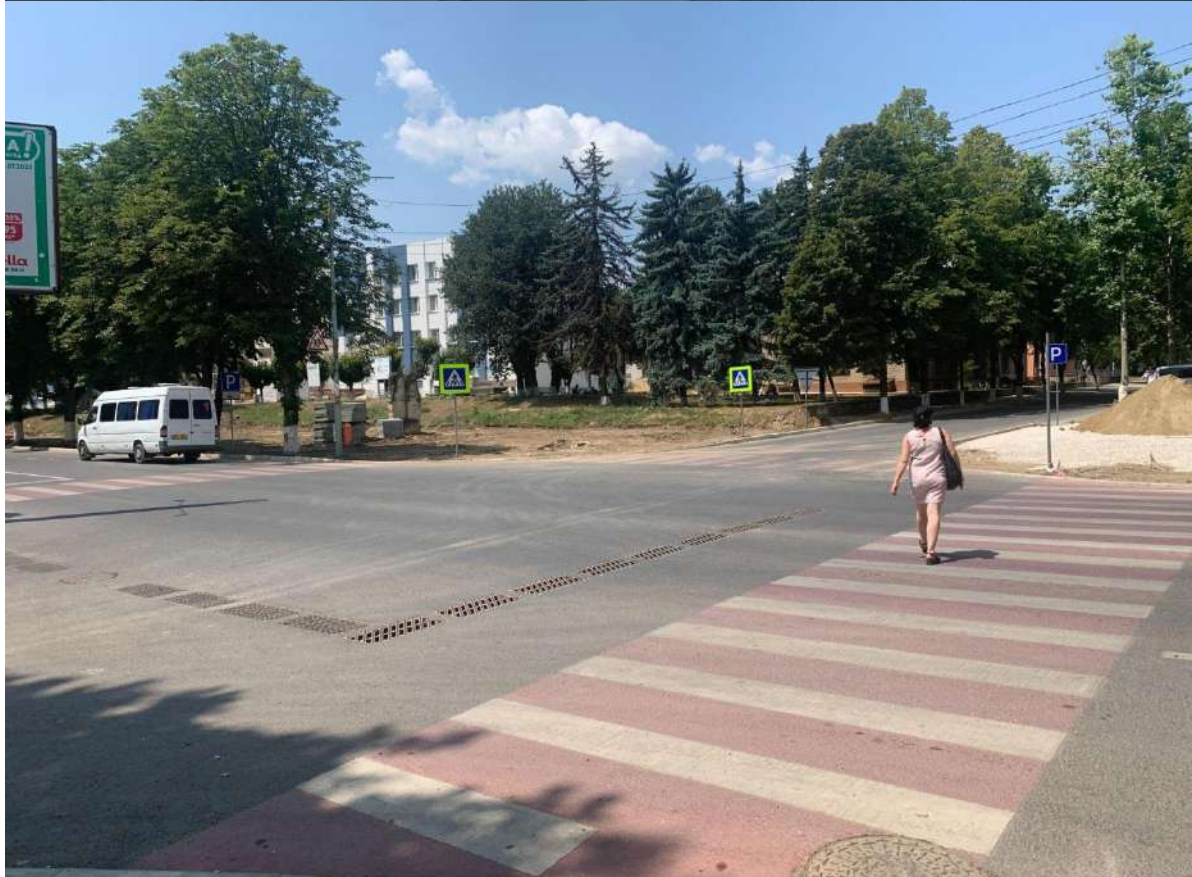
Figure 54: Pedestrian crossing area, “M. Eminescu” Lyceum, Ungheni. Source: ACM

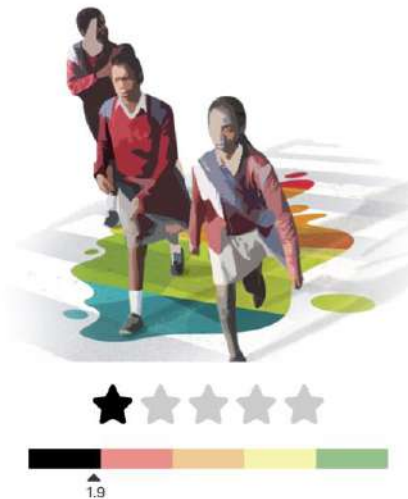
Figure 55: The safety level of the area according to the Star Rating for Schools tool. Existing situation
 Source: iRAP Demonstrator tool, ACM

Table 10 presents the Star Rating for each of the assessed locations before and after the improvements and Figures 55 and 56 shows the star ratings before and after the proposed improvements.

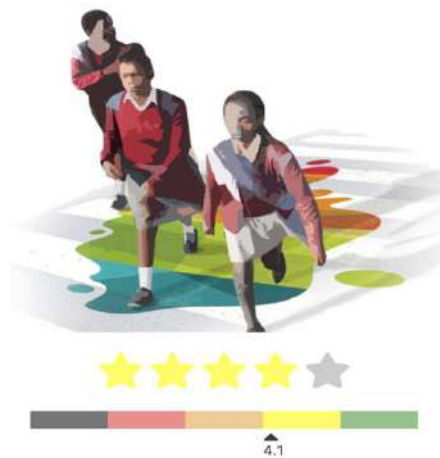
Figure 56: The safety level of the area according to the Star Rating for Schools tool. After proposed interventions. Source: iRAP Demonstrator tool, ACM.

As a result of the provided interventions the Star Rating for Schools of the assessed location can increase from 1.9 to 4.1 stars.

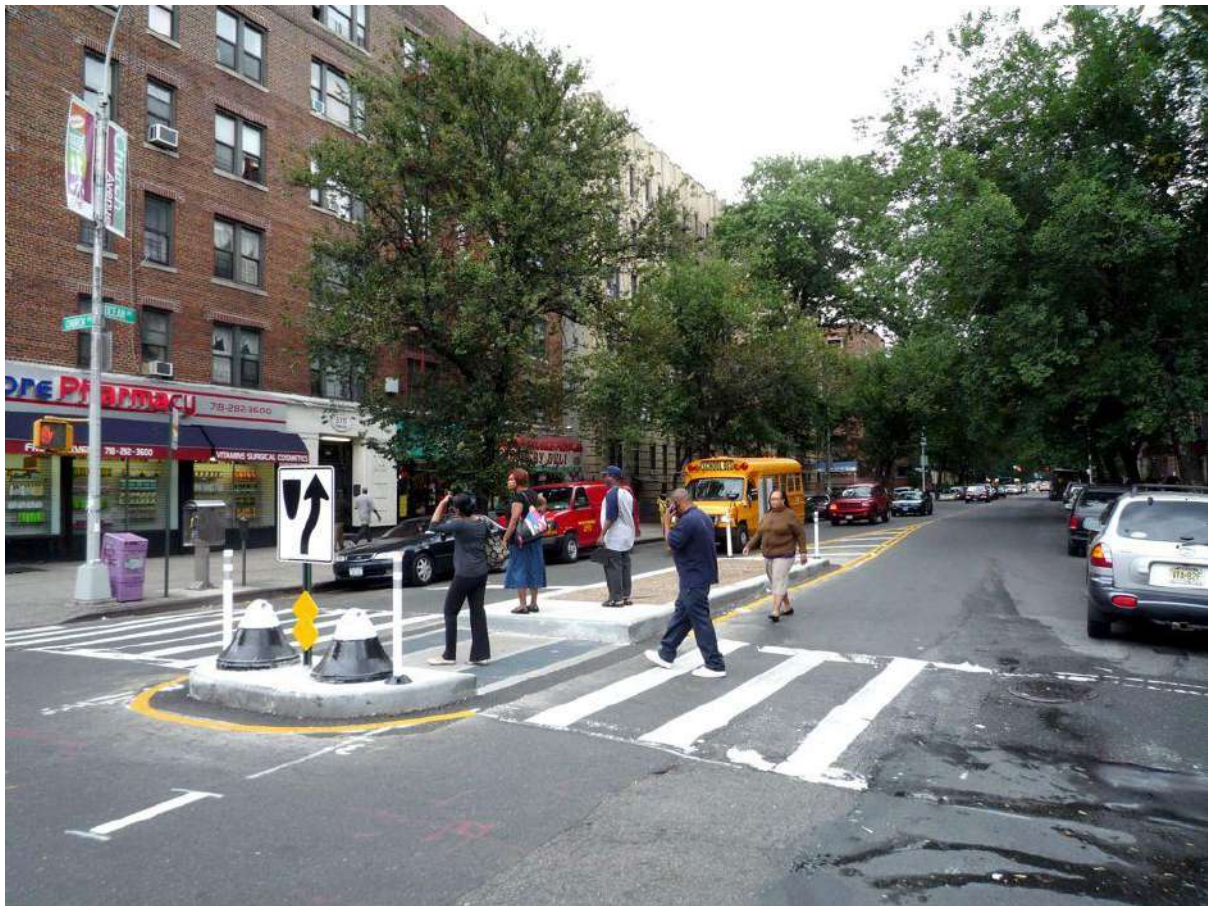
Figure 57: Example of refuge island at the intersection. Source: Google photos

Nationala Street		
Attribute	Before: 1 star	After: 4 stars
Curb radius reduced	No	Yes
Pedestrian crossings	Marked	Raised
Speed limit	40 km/h	30 km/h
Traffic calming measures	No	Yes

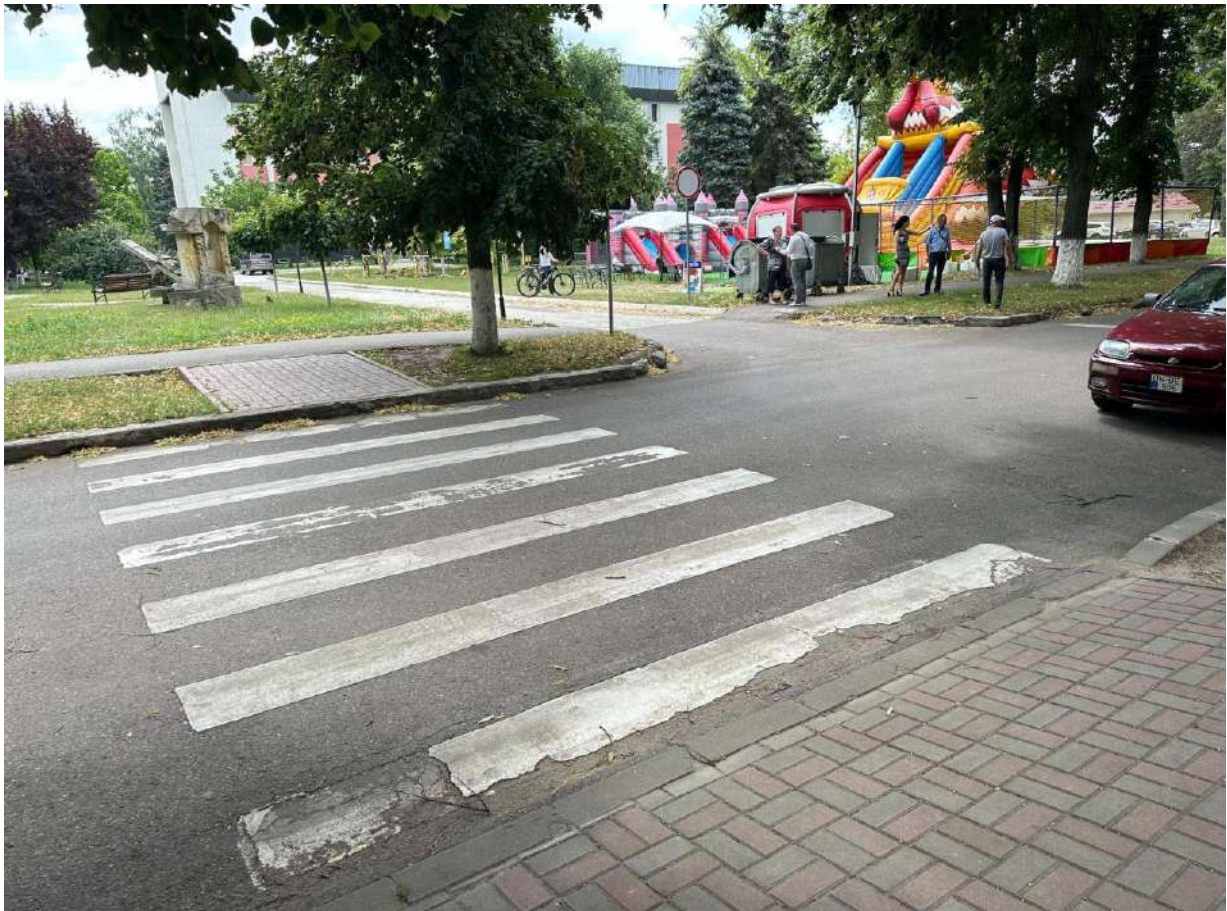
Some 50 metres before the intersection of Eminescu and Alecsandri street, there is a pedestrian crossing.

The traffic on the Eminescu street is not very intense, however the crosswalk is quite dangerous because of the parked cars along the street and it is not very accessible because of the curbs.

Figure 59: Pedestrian crossing, "Vasile Alecsandri" lyceum area, Ungheni. Source: ACM

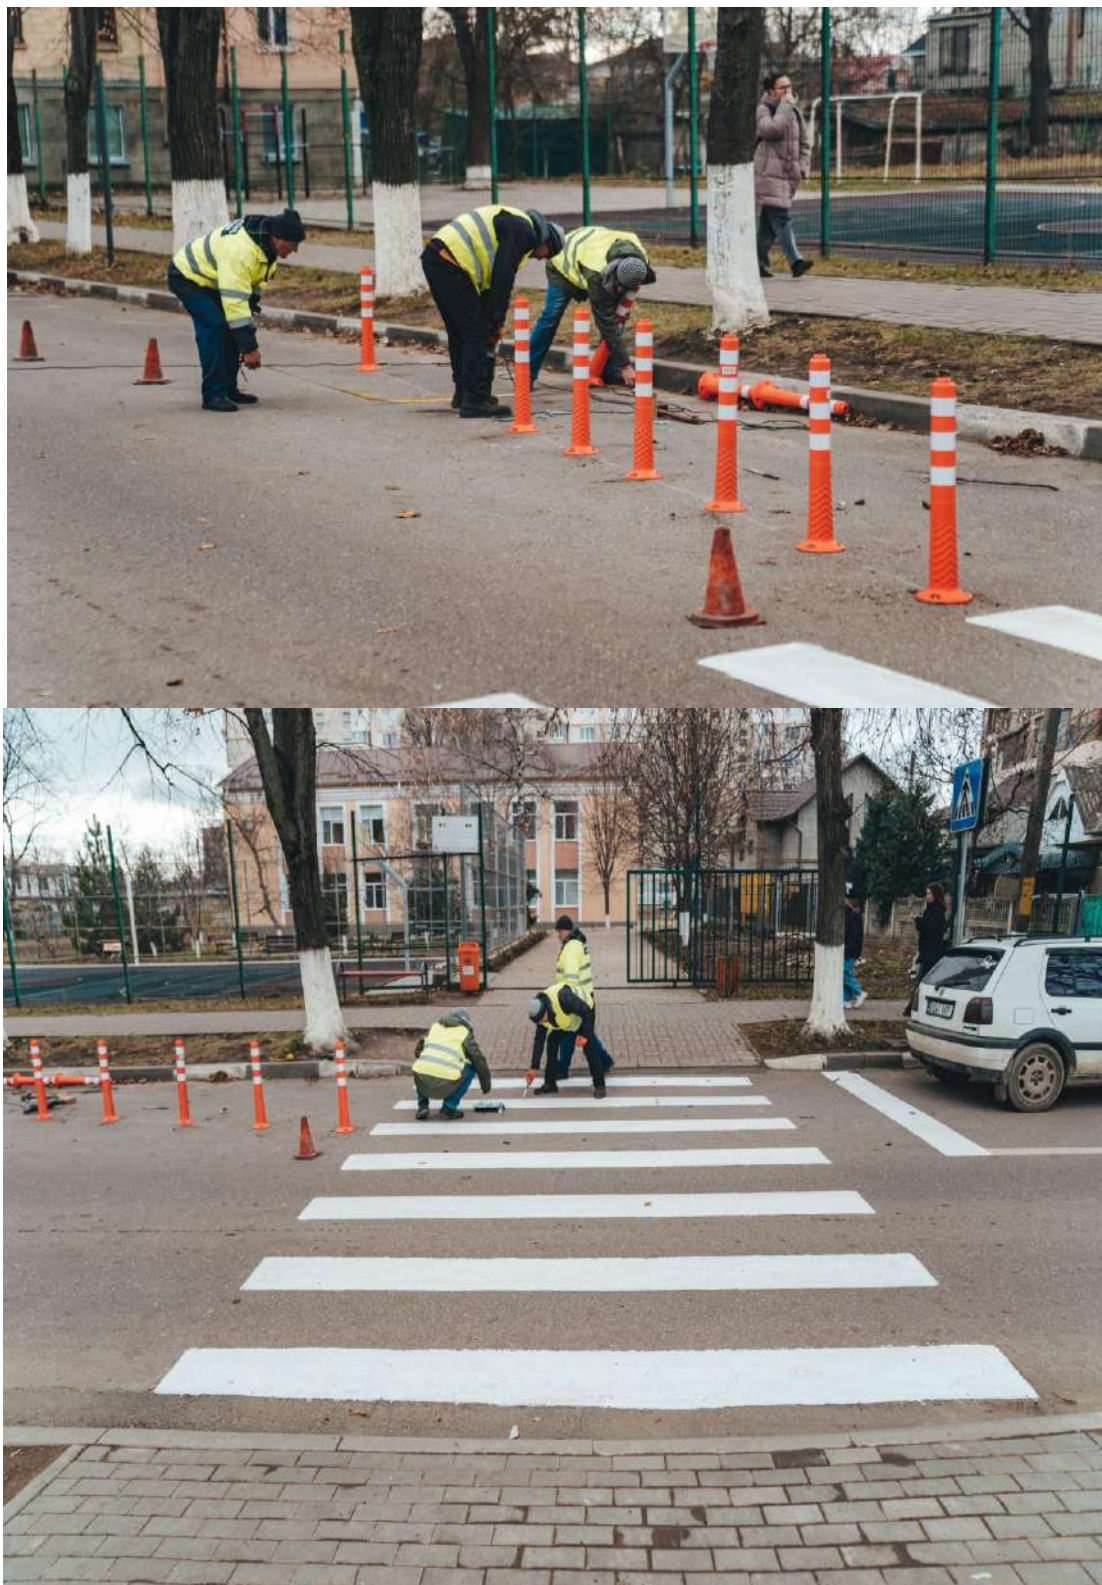
Figure 60: Pedestrian crossing, “Vasile Alecsandri” lyceum area, after proposed interventions, Ungheni. Source: ACM

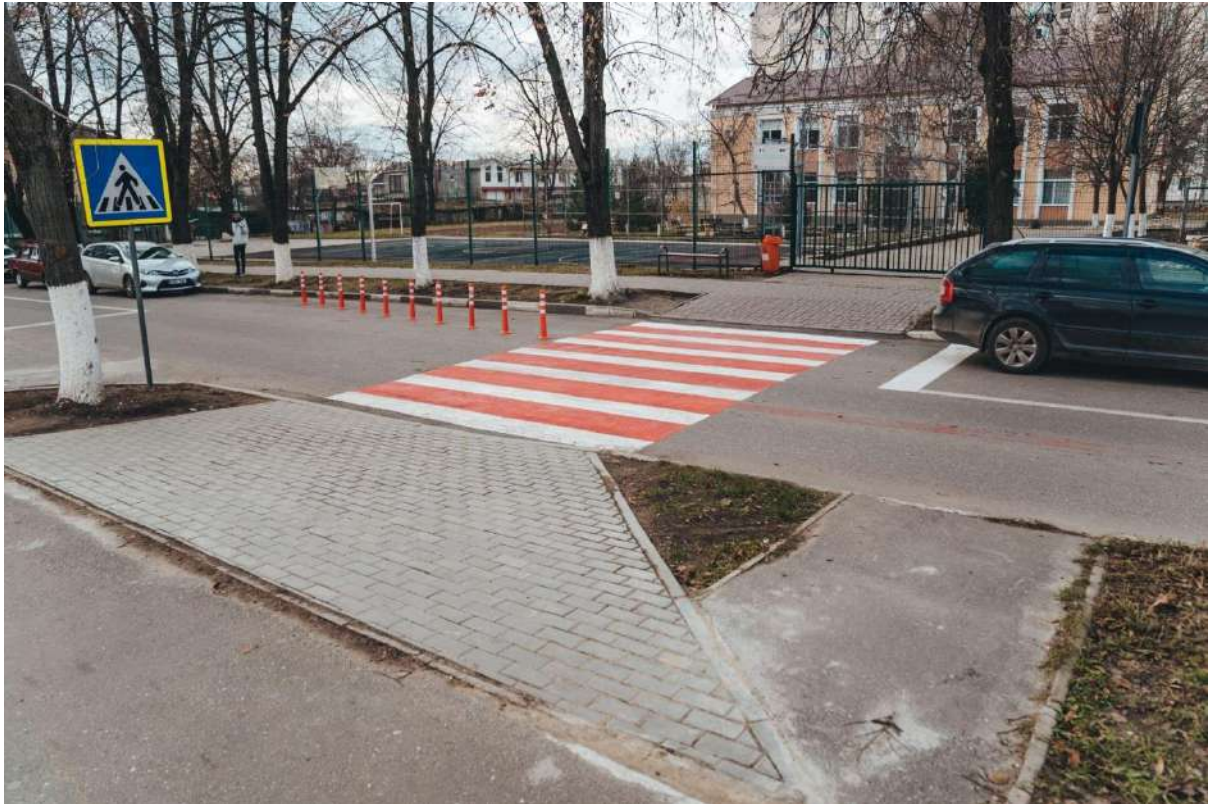
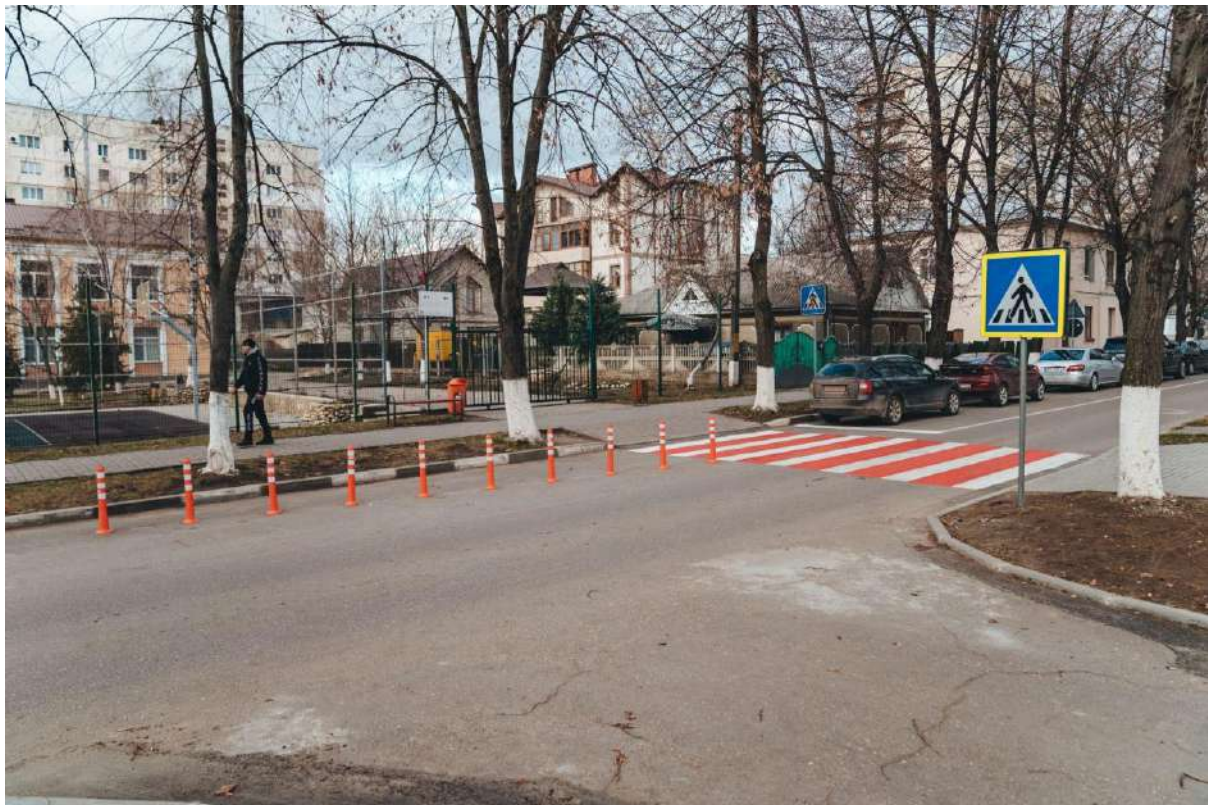
Figure 61: Pedestrian crossing, “Vasile Alecsandri” lyceum area, after proposed interventions, Ungheni. Source: ACM

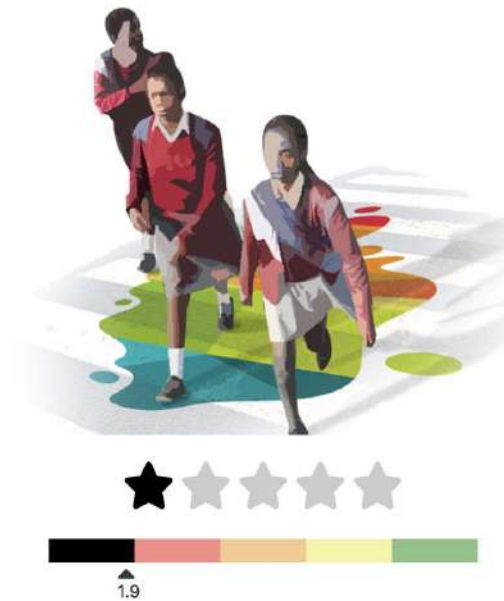
Figure 62: The safety level of the area according to the Star Rating for Schools tool. Existing situation.

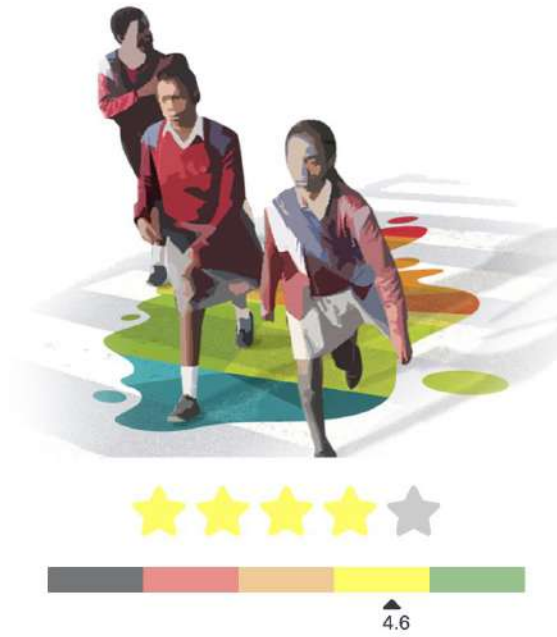
Figure 63: The safety level of the area according to the Star Rating for Schools tool. After intervention.
Source: iRAP Demonstrator tool, ACM
